MISSOURI
S&T

CENTER FOR TRANSPORTATION INFRASTRUCTURE AND SAFETY

NONDESTRUCTIVE EVALUATION OF MODOT BRIDGE DECKS – PILOT STUDY

**NUTC
R311**

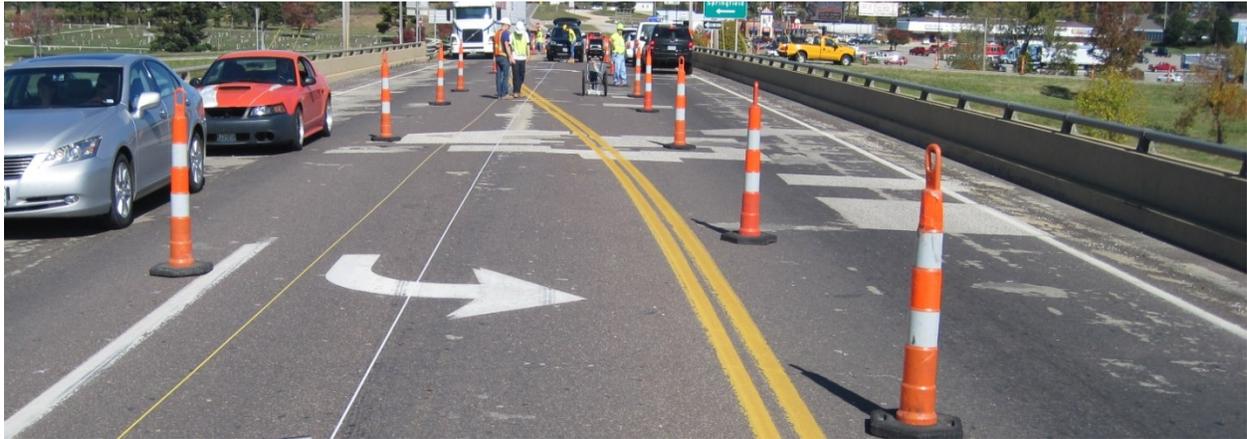
Figure 3-8 Bridge A2966 Overview of Bridge Deck Observed During Field Investigation

There were 119 defects documented during the field investigation of Bridge A2966. The deck surface had many traverse cracks, along with some concrete patches, asphalt filled potholes, and some unfilled potholes in the concrete. The deck was partially covered with a chip seal, which was worn away in many areas of the deck, especially in the wheel paths. Figure 3-8 shows an overview of the deck.

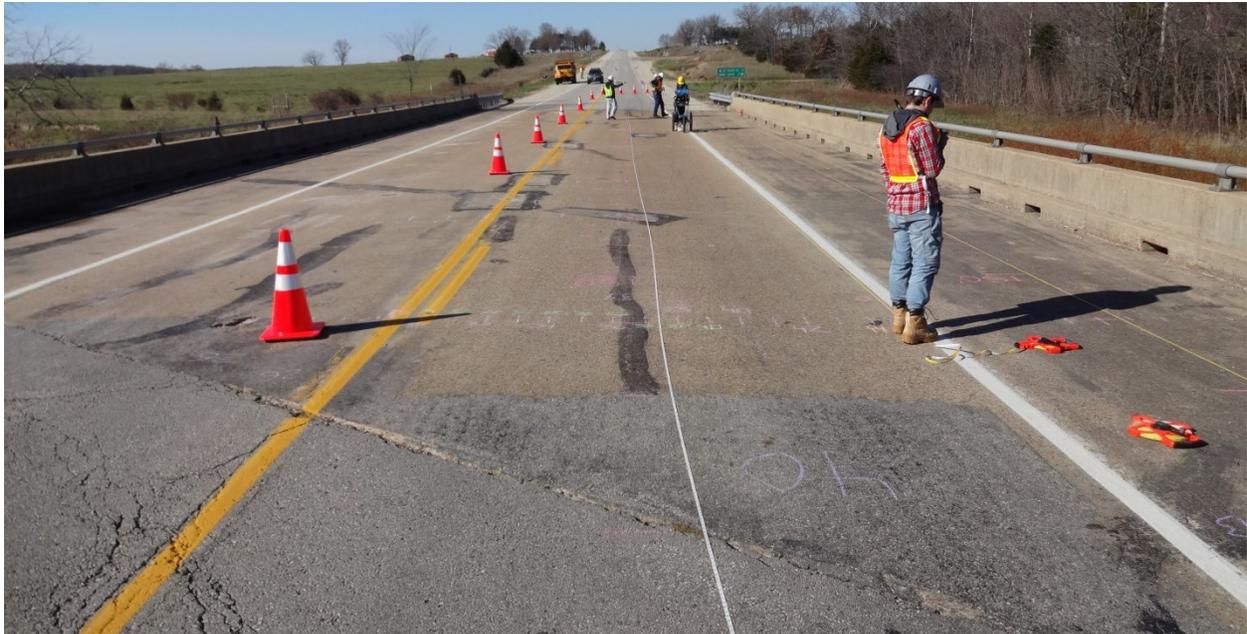
Figure 3-10 Bridge A3405 Overview of Bridge Deck Observed During Field Investigation

There were 43 defects documented on the deck surface of Bridge A3405. The majority of the defects were cracks, in both the longitudinal and transverse directions. Most of the cracks had been filled with asphalt. Some concrete patches were also observed. The ends of the bridge had asphalt wedges to allow for a smoother ride on and off the bridge. The bridge deck appeared to be in relatively good shape considering the age at investigation (38 years old). Figure 3-10 shows an overview of Bridge A3405 during the deck investigation. Darker lines in the image are cracks that have been filled with oil or bitumen.

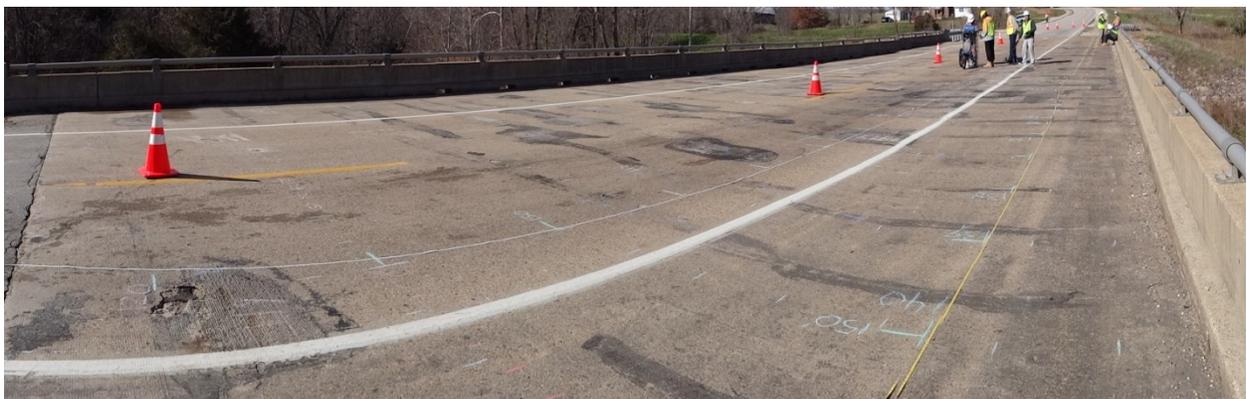
Figure 3-11 Bridge A3406 Overview of Bridge Deck Observed During Field Investigation

There were 141 defects documented during the investigation of Bridge A3406. The bridge deck surface appeared to be heavily deteriorated. Numerous transverse cracks and concrete patches were observed. The majority of the cracks were filled with oil or bitumen. Figure 3-11 shows an overview of the deck during the field investigation.

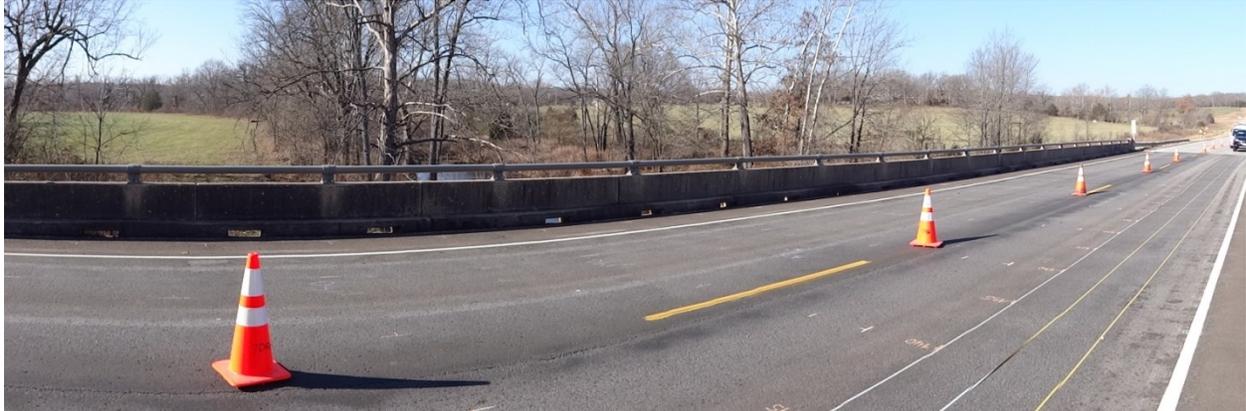
Figure 3-12 Bridge K0197 Overview of Bridge Deck Observed During Field Investigation

No visual defects were documented during the investigation of Bridge K0197. The deck had an asphalt wearing surface that appeared to be in good condition with no visible signs of deterioration. The asphalt overlay was approximately 2.5 in. as was visible in the deck curb drains. The soffit was deteriorated around the curb drains, with reinforcing steel visible in several areas. Figure 3-12 shows an overview of the deck.

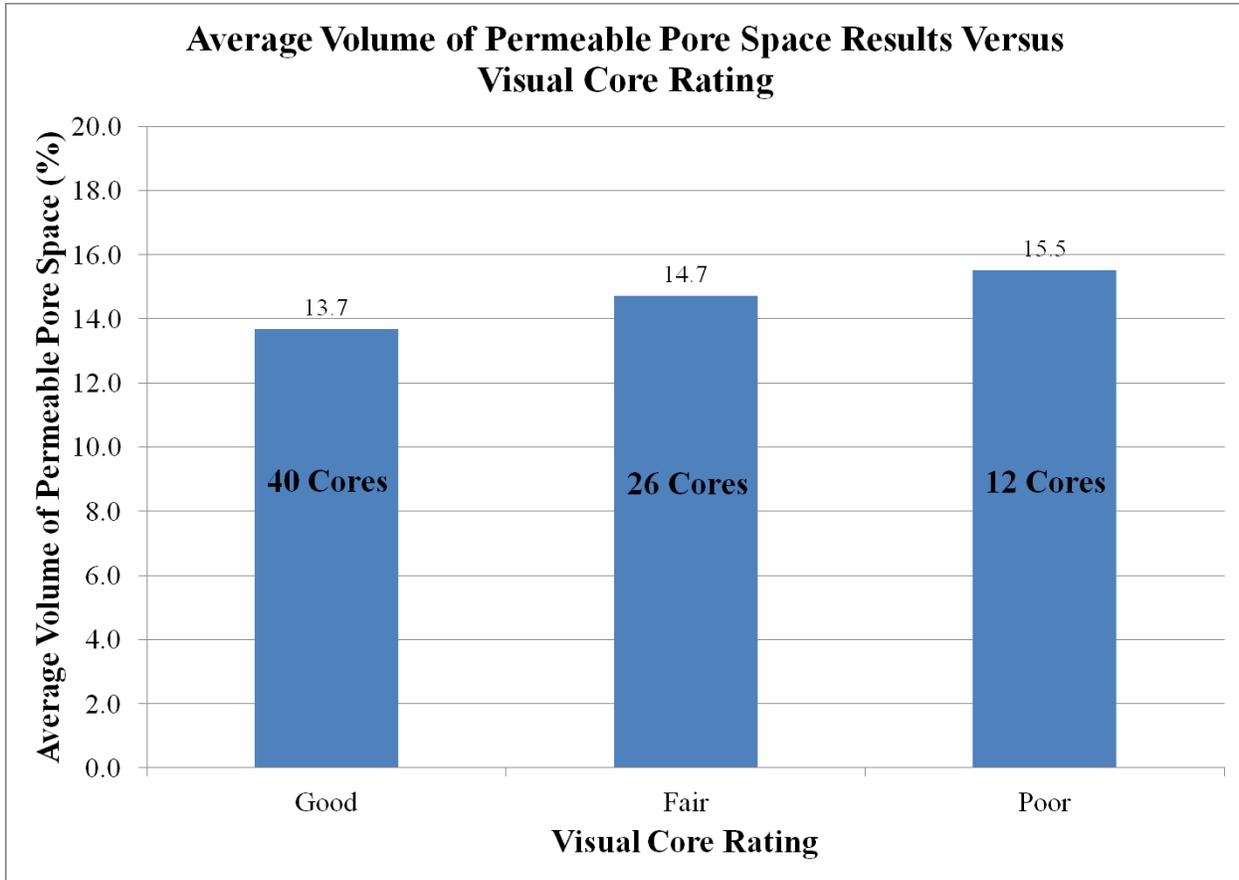
Figure 4-24 Average Volume of Permeable Pore Space Results Based on Visual Core Rating

A total of 83 cores were extracted from the 11 bridges investigated. Of those cores, 40 were rated as Good, 26 were rated as Fair, and 12 were rated as Poor using the classification system discussed in Section 4.1. The volume of permeable pore space was determined for 78 of the 83 extracted cores. Cores with no results available either consisted completely of asphalt or were too heavily deteriorated for the testing procedure. Figure 4-24 shows the average volume of permeable pore space for those cores that were assigned a visual core rating of either Good, Fair, or Poor. Figure 4-24 shows that on average, cores with higher volume of permeable core space tended to have a lower visual core rating.

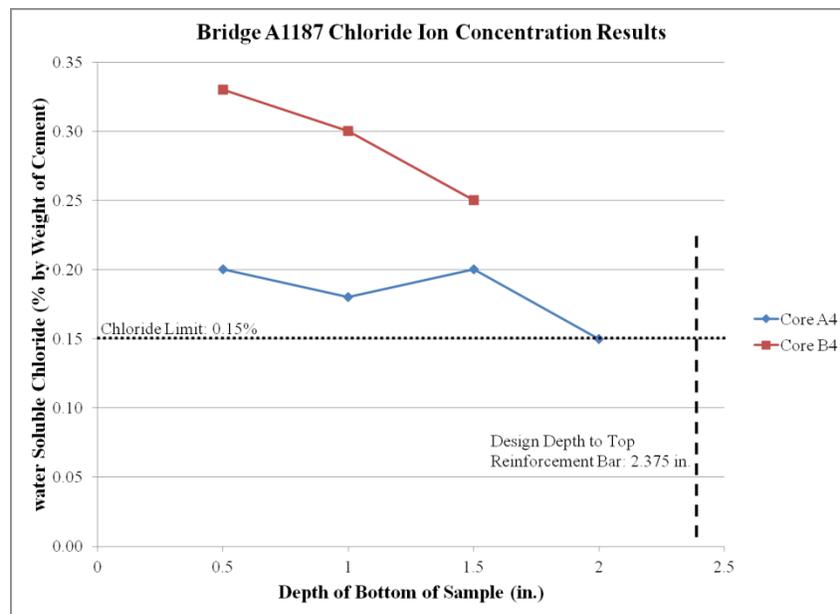
Figure 5-2 Bridge A1187 Chloride Ion Concentration Results

Figure 5-2 shows the chloride ion concentration results for Cores A4 and B4 from Bridge A1187. Results were not available at the design depth of top reinforcing bar, but projection of the trends in the figure suggest that chloride ion concentration levels would be slightly below the threshold limit for both cores.

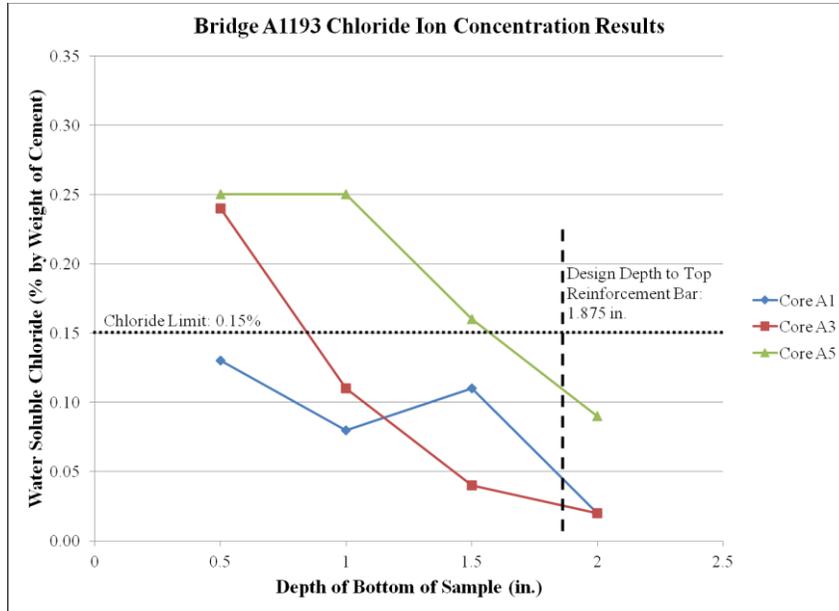
Figure 5-3 Bridge A1193 Chloride Ion Concentration Results

Figure 5-3 shows the chloride ion concentration results for Cores A1, A3, and A5 from Bridge A1193. Results indicate that chloride ion concentration levels are less than the threshold limit for each core.

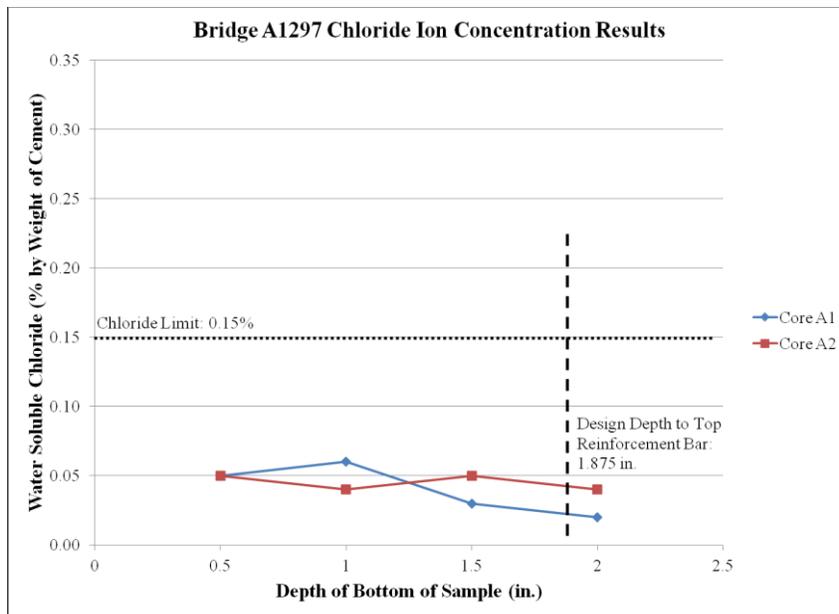
Figure 5-4 Bridge A1297 Chloride Ion Concentration Results

Figure 5-4 shows the chloride ion concentration results for Cores A1 and A2 from Bridge A1297. Results indicate that chloride ion concentration levels are less than the threshold limit for both cores.

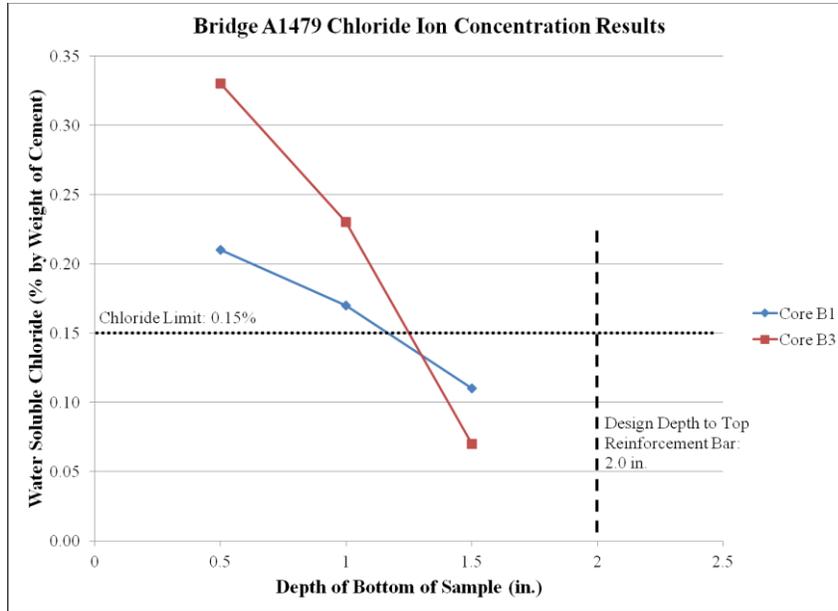
Figure 5-5 Bridge A1479 Chloride Ion Concentration Results

Figure 5-5 shows the chloride ion concentration results for Cores B1 and B3 from Bridge A1479. Results were not available at the design depth of top reinforcing bar, but projection of the trends in the figure suggest that chloride ion concentration levels would be below the threshold limit for both cores.

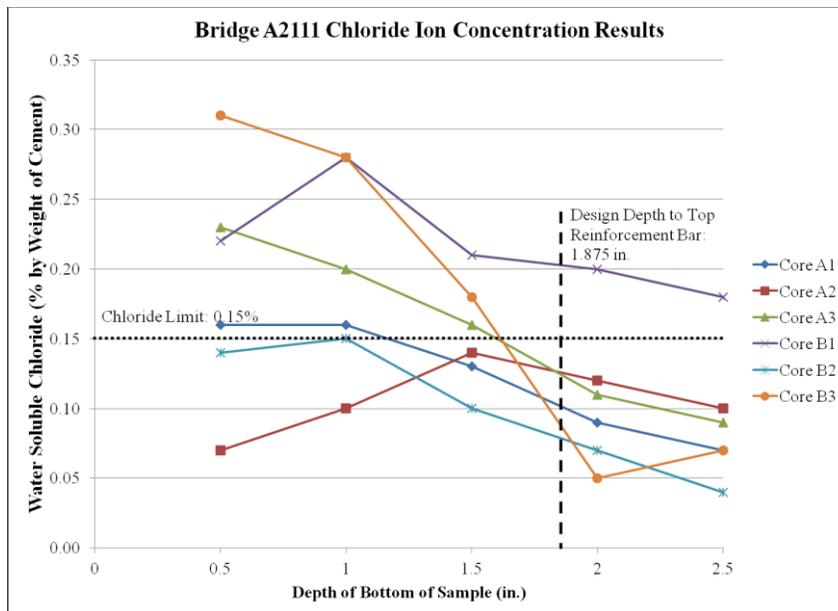
Figure 5-6 Bridge A2111 Chloride Ion Concentration Results

Figure 5-6 shows the chloride ion concentration results for Cores A1, A2, A3, B1, B2, and B3 from Bridge A2111. Results indicate that chloride ion concentration levels are less than the threshold limit for each core with the exception of Core B1, which had a measured chloride ion concentration above the threshold limit.

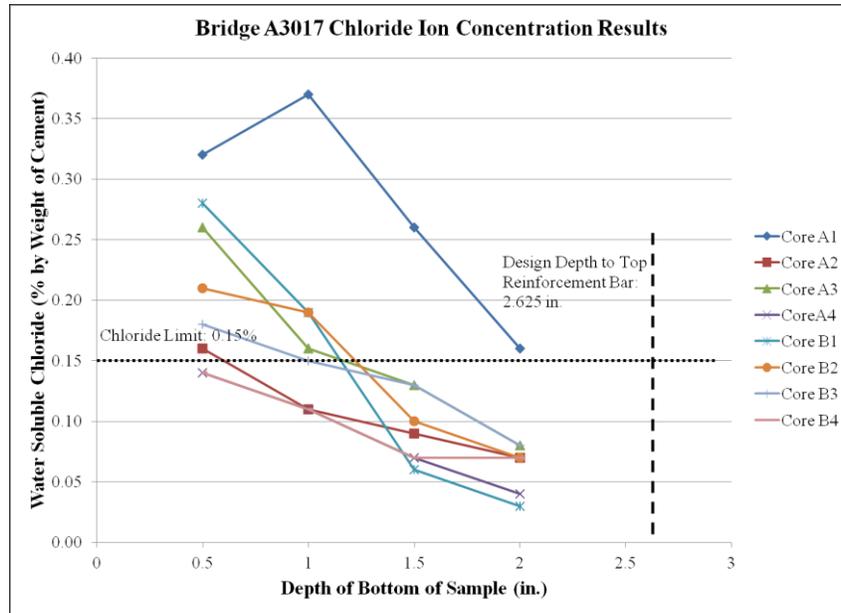
Figure 5-7 Bridge A3017 Chloride Ion Concentration Results

Figure 5-7 shows the chloride ion concentration results for Cores A1, A2, A3, A4, B1, B2, B3, and B4 from Bridge A3017. Results were not available at the design depth of top reinforcing bar, but projection of the trends in the figure suggest that chloride ion concentration levels would be below the threshold limit for each core.

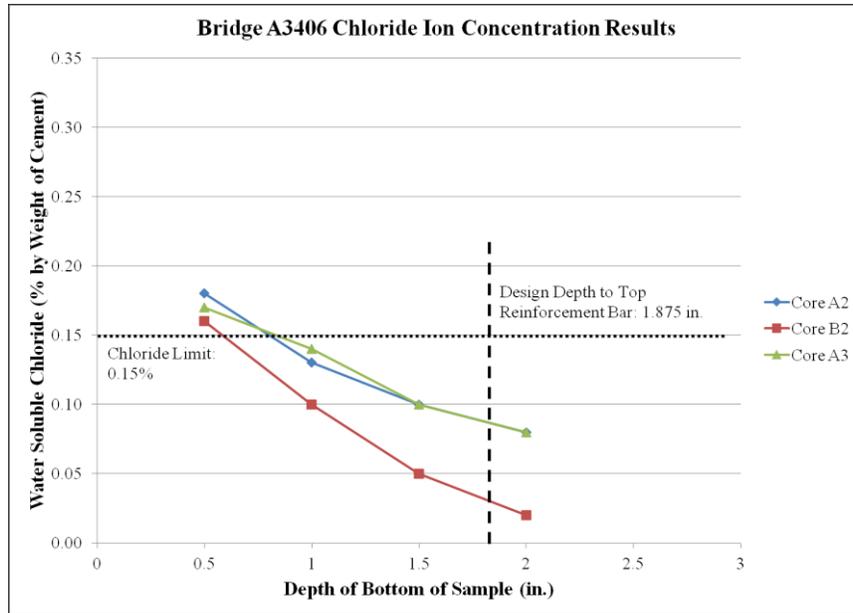
Figure 5-8 Bridge A3406 Chloride Ion Concentration Results

Figure 5-8 shows the chloride ion concentration results for Cores A2, A3, and B2 from Bridge A3406. Results indicate that chloride ion concentration levels are less than the threshold limit for each core.

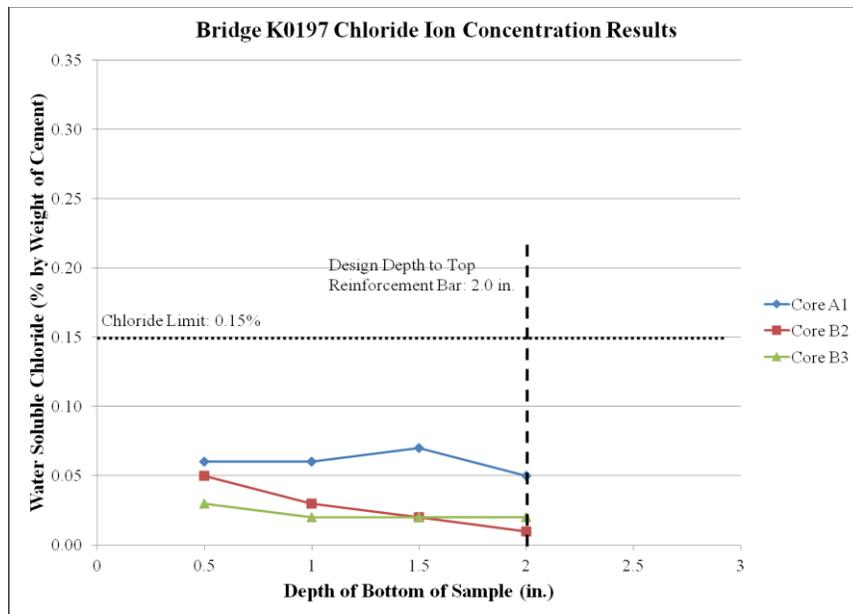
Figure 5-9 Bridge K0197 Chloride Ion Concentration Results

Figure 5-9 shows the chloride ion concentration results for Cores A1, B2, and B3 from Bridge K0197. Results indicate that chloride ion concentration levels are less than the threshold limit for each core.

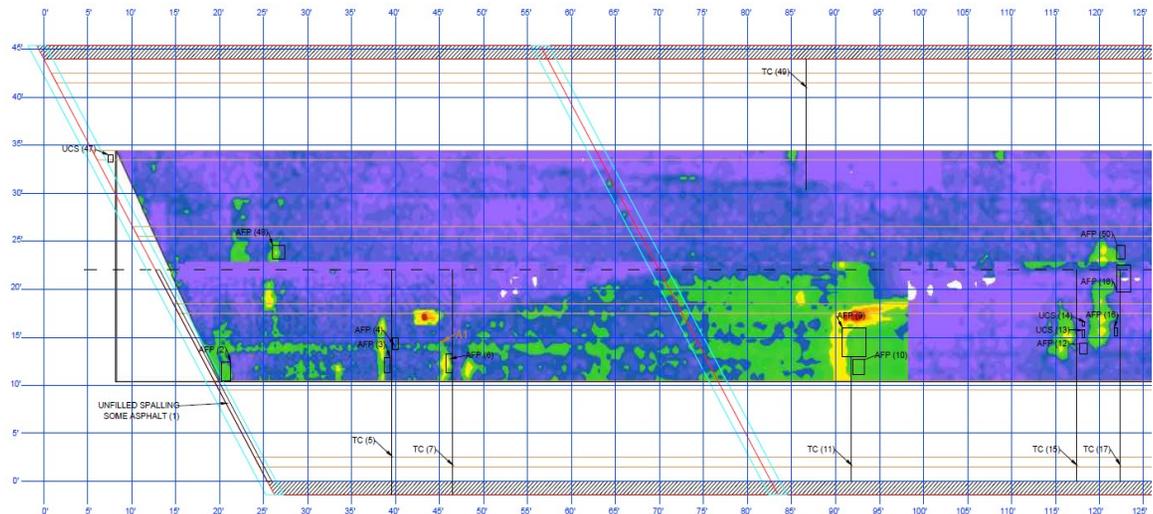
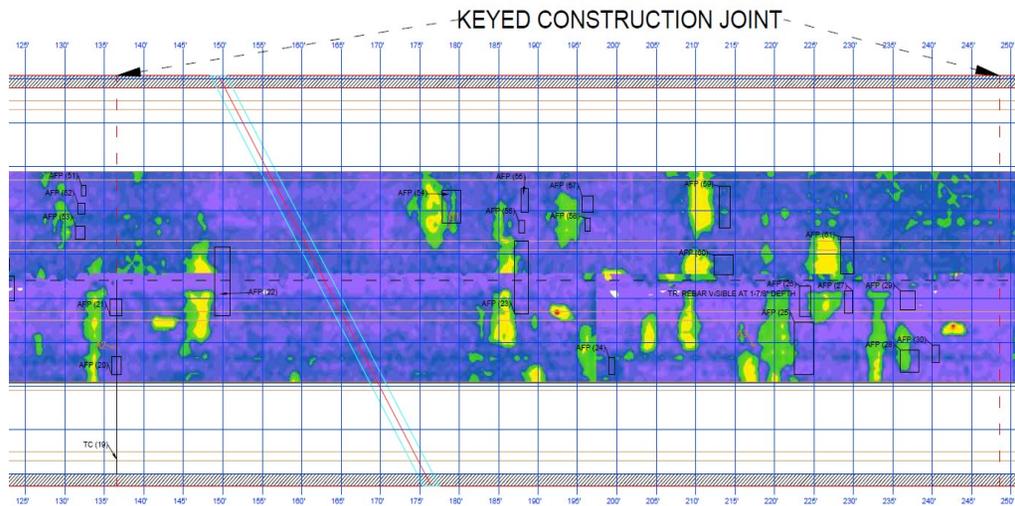
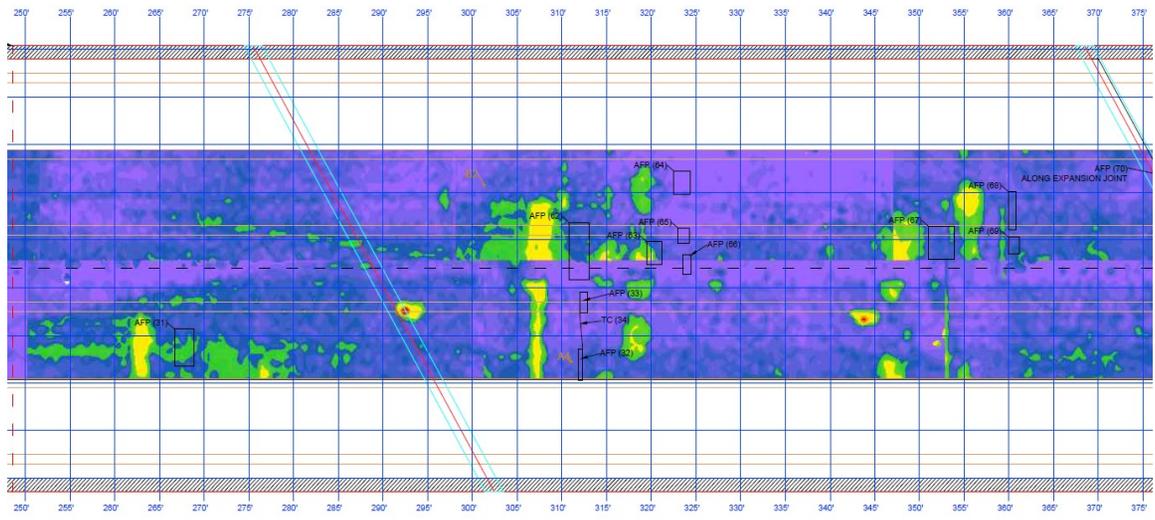
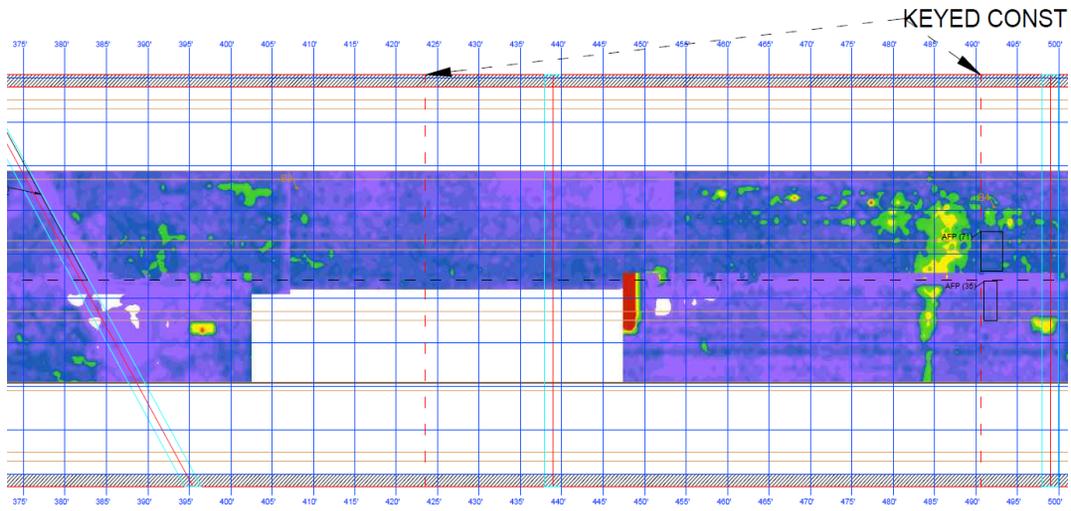
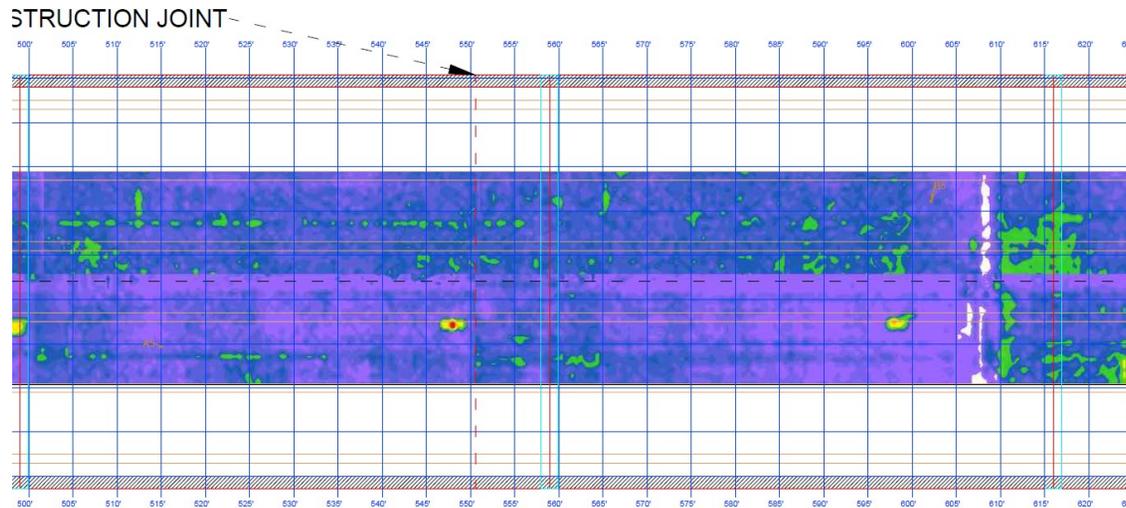
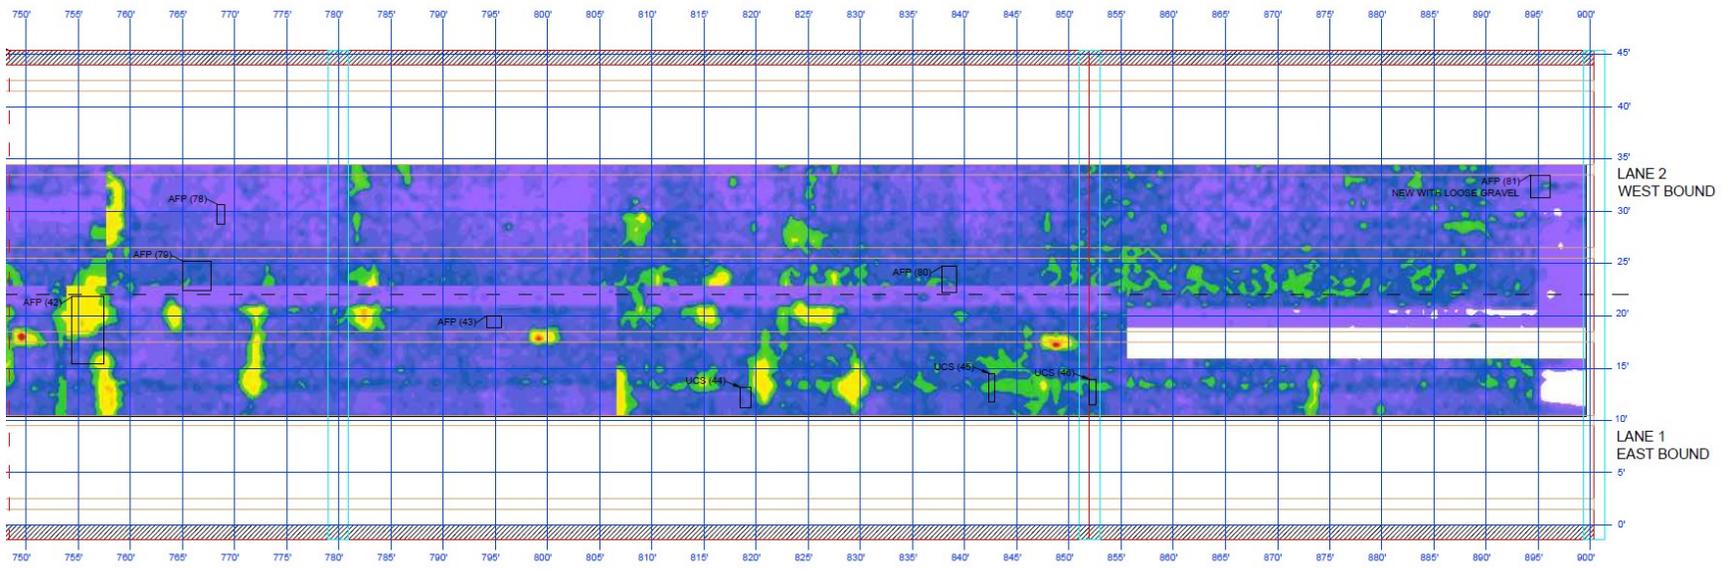
Figure 6-5 Bridge A1193 Drawing Including Lidar Rehabilitation Survey and Visual Investigation Results

Figure 6-5 shows the lidar scan results for Bridge A1193 in 125 ft. long segments. The scale for depth difference (corresponding to thickness of material removal) for the lidar results in Figure 6-5 is shown in Figure 6-6. It should be noted that data were not captured in certain areas of the deck, therefore these segments were omitted and are not plotted in Figure 6-5. The amount (percentage of surface area surveyed) of concrete removed in each of the three categories defined in Section 6.1 is shown in Figure 6-7.

Comparing Figures 7-12 and 7-13, it can be seen that areas of the bridge deck where the GPR amplitude map indicates evidence of extensive deterioration generally correspond to areas with greater concrete material removal depths based on the lidar survey after hydrodemolition. Similarly, areas where the GPR amplitude map indicates moderate or no evidence of deterioration generally correspond to areas with lesser concrete material removal depths. Figure 7-1 compares the percentage of the bridge deck within each of the three categories defined for the GPR grade classification with three categories defined for depth of concrete material removed. It should be noted that a perfect correlation was not expected because the GPR grade classifications and the material removal depth categories have different meanings; see Section 7.4.2 for further discussion.

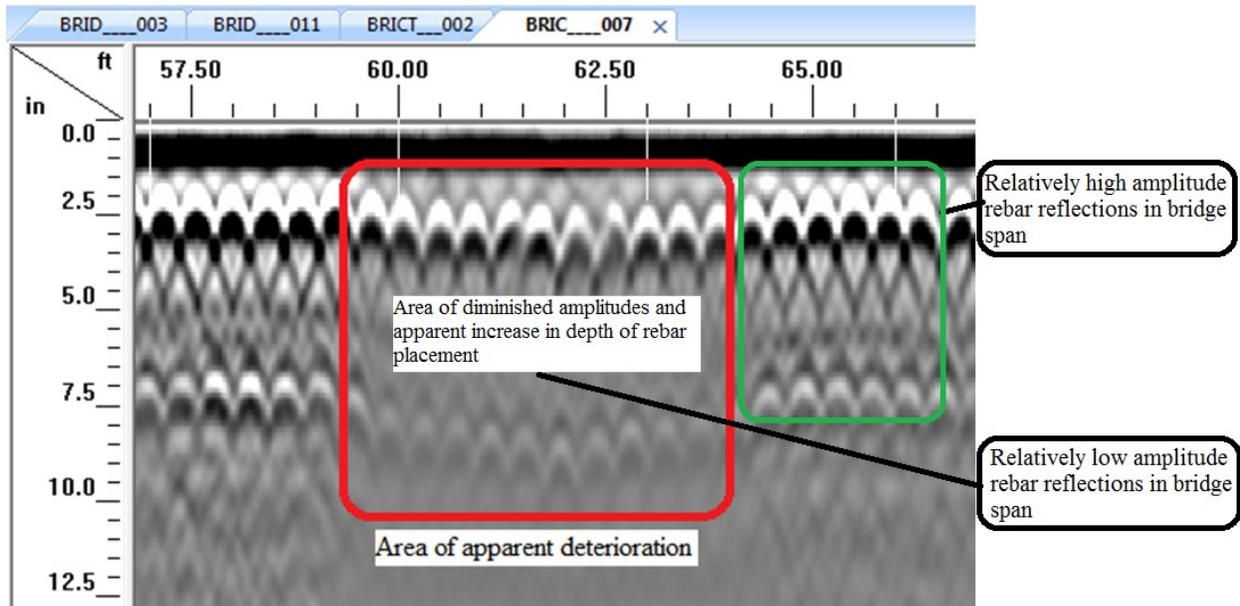
Figure 7-5 Example of GPR Data Showing Variation of the Apparent Embedment Depth of Top and Bottom Layers of Rebar. Greater Apparent Embedment Depths are Normally an Indication of Deterioration.

in the apparent embedment depth of the top layer of rebar were noted since greater apparent embedment depth is usually indicative of greater concrete deterioration (Figure 7-5). After correlating the GPR results with the visual evaluation of the cores (discussed in Section 4), reflection amplitude ranges for three deterioration categories were defined. The three categories defined are: “no evidence of deterioration,” “evidence of moderate deterioration,” and “evidence of extensive deterioration,” corresponding to relatively high reflection amplitude, moderate reflection amplitude, and low reflection amplitude, respectively. The amplitude range for each category was determined by the researchers for each individual bridge deck, and graphs were developed to show the predicted distribution of deterioration of each bridge deck in terms of deck surface area investigated.

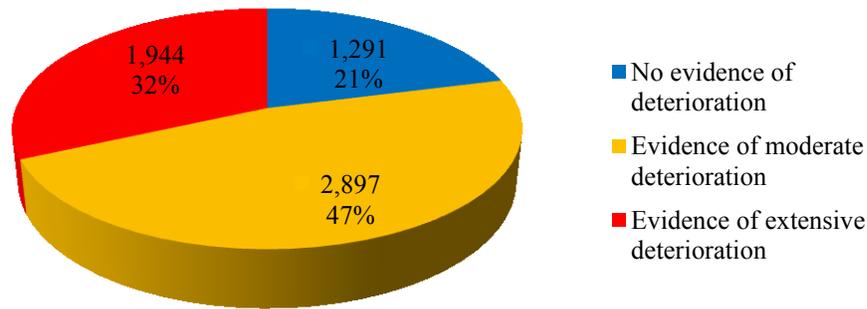
Figure 7-7 shows that 21% of the area investigated on the bridge deck of Bridge A0596 exhibited no evidence of deterioration, 47% exhibited evidence of moderate deterioration, and 32% exhibited evidence of extensive deterioration based on the deterioration categories defined for the GPR amplitude results.

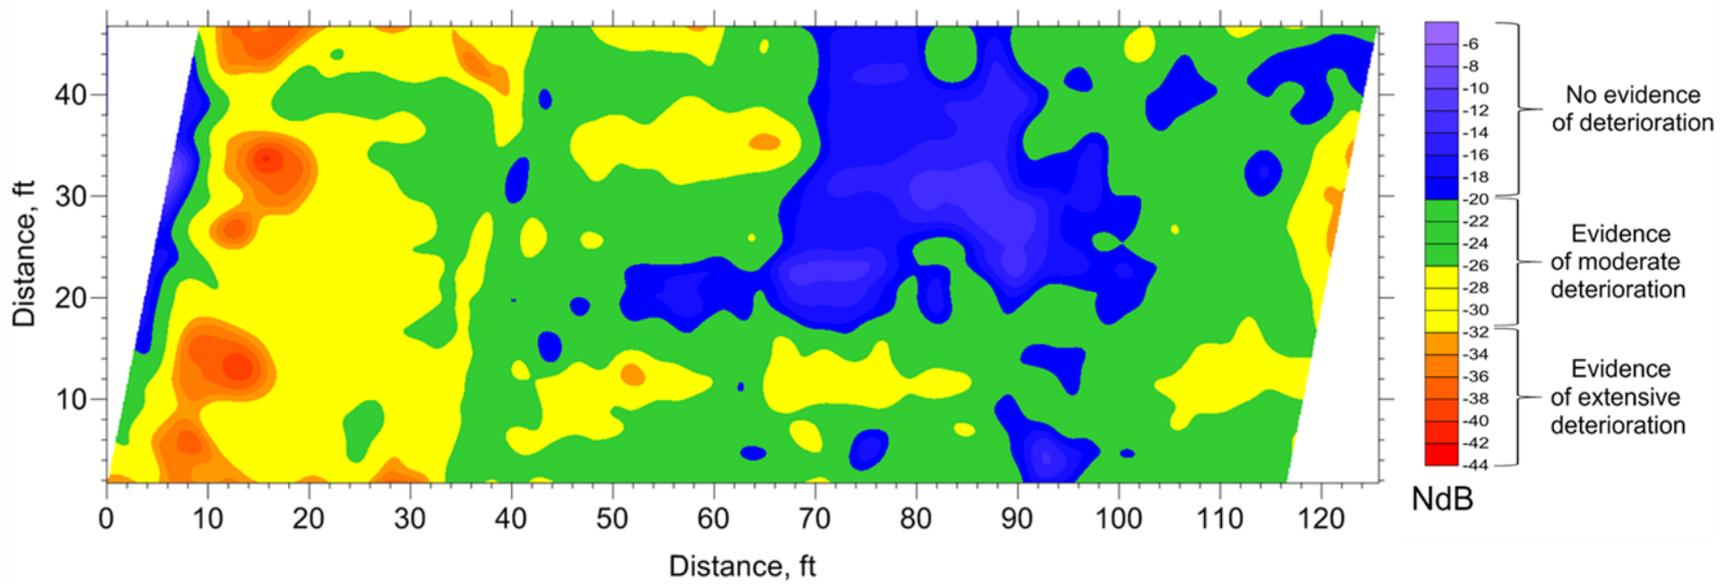
Figure 7-9 GPR Amplitude Map Based on Top Bar Reflection for Bridge Deck A1187 with Superposed Core Locations and Visual Surface Condition Features, After Resurfacing

The GPR data were acquired along parallel traverses spaced at 1 ft intervals. The acquisition parameters employed were 512 samples/scan, 120 scans/second, and 90 scans/ft. The dielectric constant was assumed to be 10.0. Map of reflection amplitudes from the top layer of transverse rebar are shown in Figures 7-8 and 7-9, before and after resurfacing, respectively. Amplitude ranges for three deterioration categories shown in Figure 7-8 were defined based on correlation of the GPR data with the visual evaluation of the cores. Area and percentage distribution of all three deterioration categories were calculated for the bridge deck area, before and after resurfacing, are shown in Figure 7-10 and 7-11, respectively.

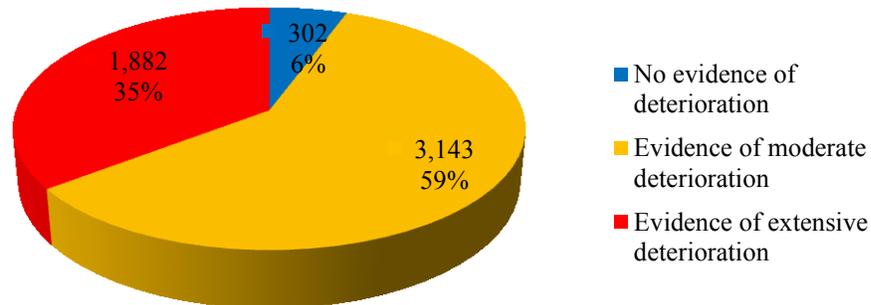
Bridge A1187 (prior to resurfacing)

Figure 7-10 Graph Showing Predicted Distribution of Deterioration of the Bridge Deck A1187 (Investigated Area; Prior to Resurfacing) in Each Category (Based on the Amplitude of the Reflection from the Top Layer of Rebar). Total Area Investigated - 5,327 ft²; No Evidence of Deterioration - 302 ft²; Evidence of Moderate Deterioration - 3,143 ft²; Evidence of Extensive Deterioration 1,882 ft².

Figure 7-10 shows that 6% of the area investigated on the bridge deck of Bridge A1187 exhibited no evidence of deterioration, 59% exhibited evidence of moderate deterioration, and 35% exhibited evidence of extensive deterioration based on the deterioration categories defined for the GPR amplitude results.

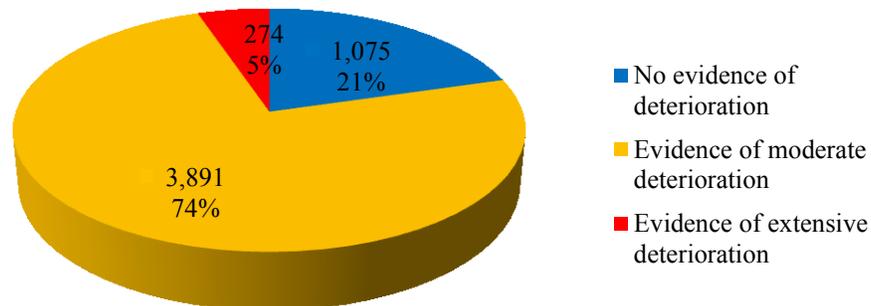
Bridge A1187 (after resurfacing)

Figure 7-11 Graph Showing Predicted Distribution of Deterioration of the Bridge Deck A1187 (Investigated Area; After Resurfacing) in Each Category (Based on the Amplitude of the Reflection from the Top Layer of Rebar). Total Area Investigated - 5,240 ft²; No Evidence of Deterioration - 1,075 ft²; Evidence of Moderate Deterioration - 3,891 ft²; Evidence of Extensive Deterioration 274 ft².

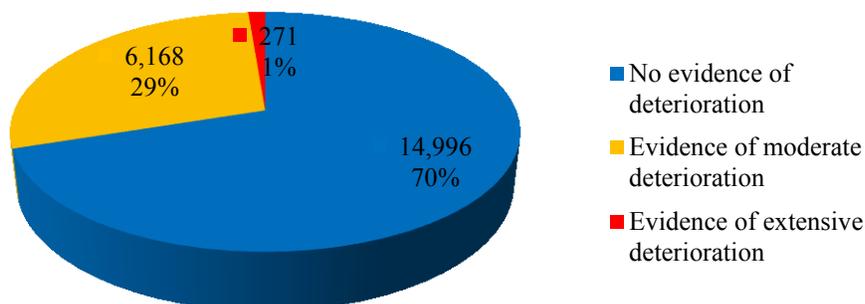
Figure 7-14 Graph Showing Predicted Distribution of Deterioration of the Bridge Deck A1193 in Each Category (Based on the Amplitude of the Reflection from the Top Layer of Rebar). Total Area Investigated - 21,435 ft²; No Evidence of Deterioration – 14,996 ft²; Evidence of Moderate Deterioration - 6,168 ft²; Evidence of Extensive Deterioration 271 ft².

Figure 7-14 shows that 70% of the area investigated on the bridge deck of Bridge A1193 exhibited no evidence of deterioration, 29% exhibited evidence of moderate deterioration, and 1% exhibited evidence of extensive deterioration based on the deterioration categories defined for the GPR amplitude results.

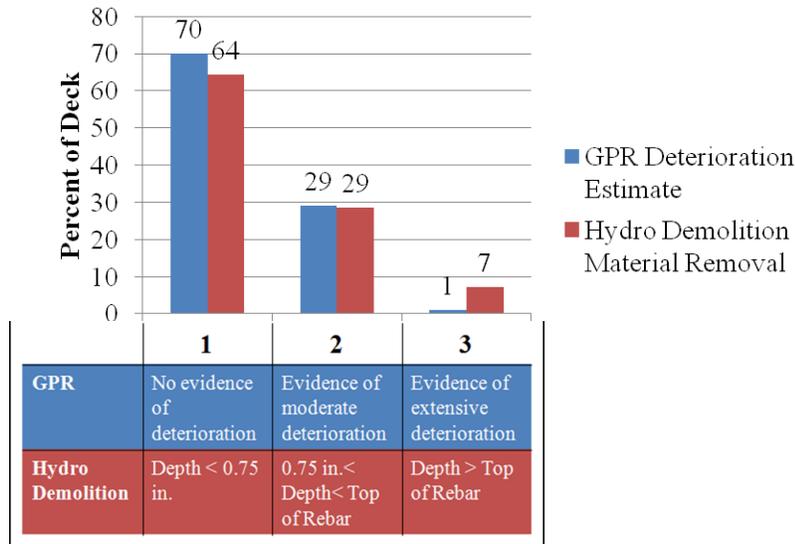
Figure 7-15 Percentage of Bridge Deck Area for Bridge A1193 Categorized by GPR Results and Rehabilitation Lidar Survey

For a quantitative comparison, Figures 7-15, 7-19, and 7-23 compare the percentage of the bridge deck within each of the three categories defined for the GPR grade classification with the percentage of the deck within the three categories defined for depth of concrete material removed. Although good correlation between the two classifications is observed in Figure 7-15 for Bridge A1193, the correlations in Figures 7-19 and 7-23 for Bridges A1297 and A1479 are

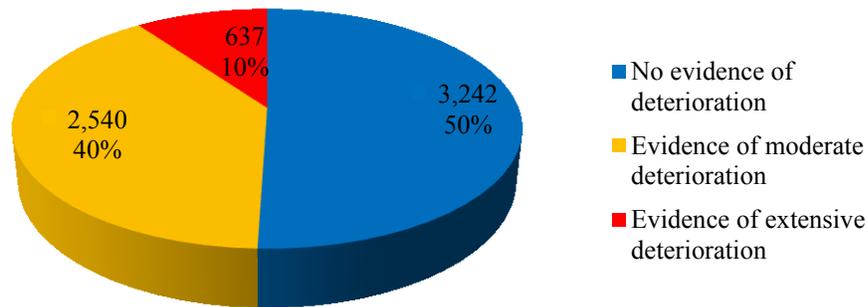
Figure 7-18 Graph Showing Predicted Distribution of Deterioration of the Bridge Deck A1297 in Each Category (Based on the Amplitude of the Reflection from the Top Layer of Rebar). Total Area Investigated - 6,419 ft²; No Evidence of Deterioration – 3,242 ft²; Evidence of Moderate Deterioration - 2,540 ft²; Evidence of Extensive Deterioration 637 ft².

Figure 7-18 shows that 50% of the area investigated on the bridge deck of Bridge A1297 exhibited no evidence of deterioration, 40% exhibited evidence of moderate deterioration, and 10% exhibited evidence of extensive deterioration based on the deterioration categories defined for the GPR amplitude results.

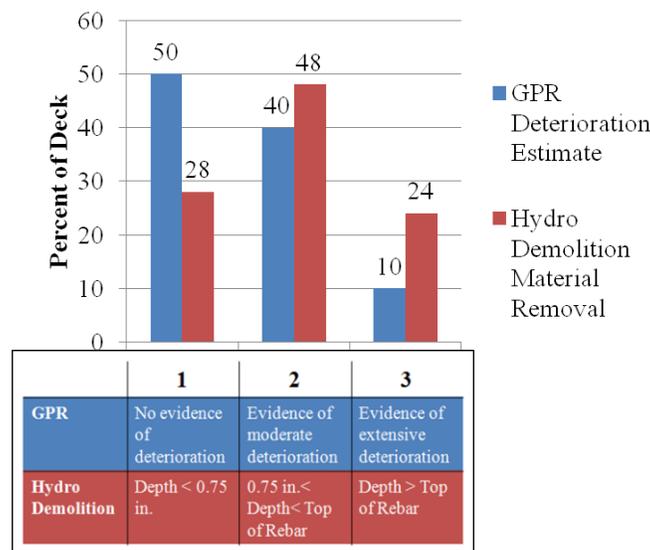
Figure 7-19 Percentage of Bridge Deck Area for Bridge A1297 Categorized by GPR Results and Rehabilitation Lidar Survey

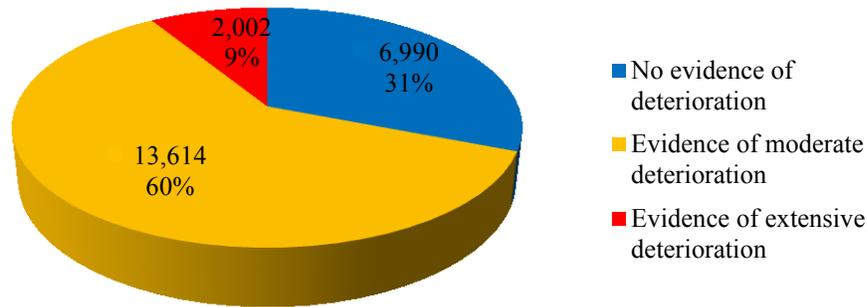
Figure 7-22 Graph Showing Predicted Distribution of Deterioration of the Bridge Deck A1479 in Each Category (Based on the Amplitude of the Reflection from the Top Layer of Rebar). Total Area Investigated - 22,606 ft²; No Evidence of Deterioration – 6,990 ft²; Evidence of Moderate Deterioration - 13,614 ft²; Evidence of Extensive Deterioration 2,002 ft².

Figure 7-22 shows that 31% of the area investigated on the bridge deck of Bridge A1479 exhibited no evidence of deterioration, 60% exhibited evidence of moderate deterioration, and 9% exhibited evidence of extensive deterioration based on the deterioration categories defined for the GPR amplitude results.

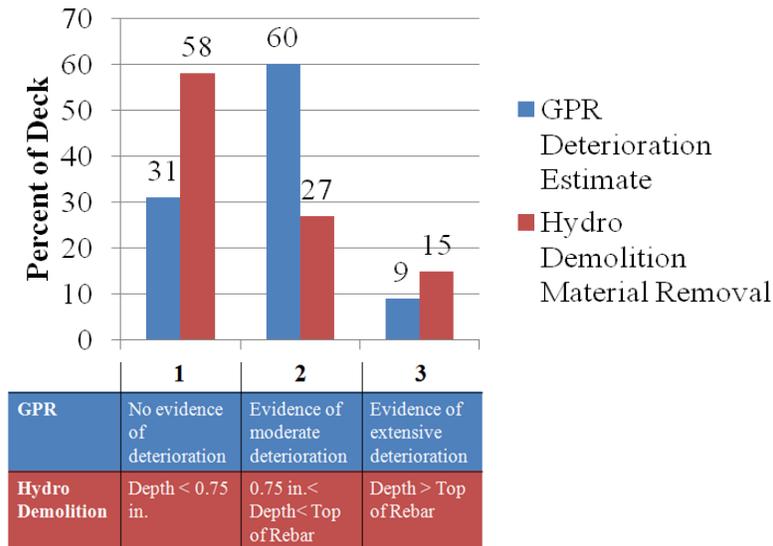
Figure 7-23 Percentage of Bridge Deck Area for Bridge A1479 Categorized by GPR Results and Rehabilitation Lidar Survey

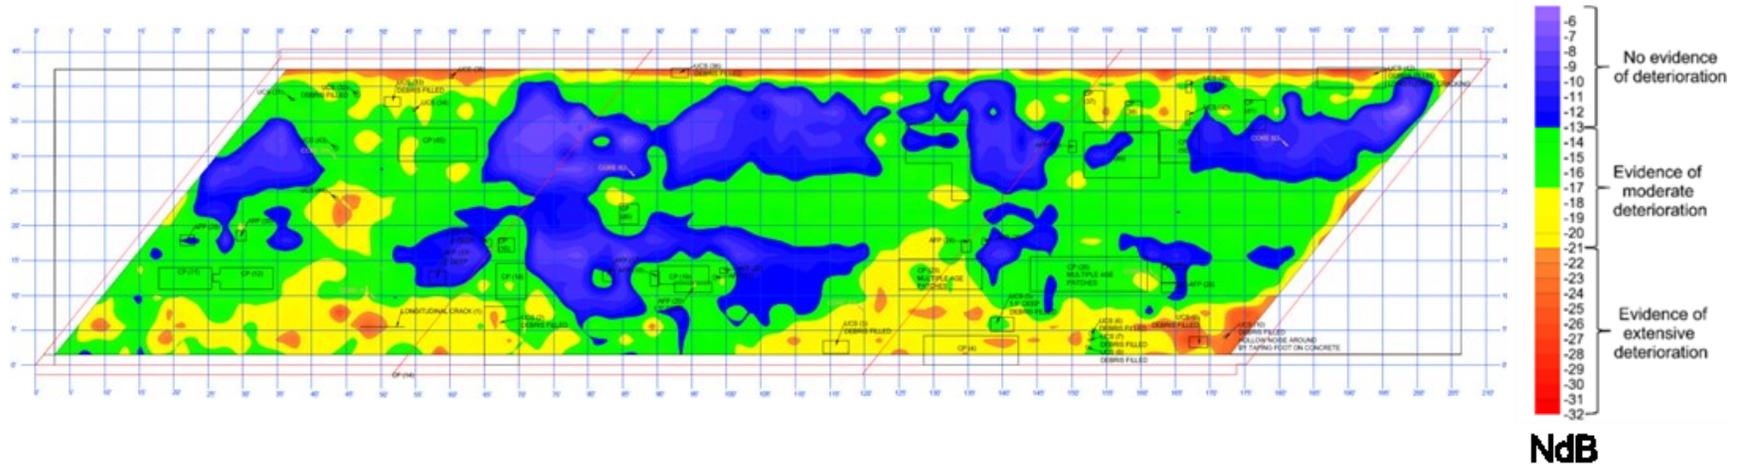
Figure 7-24 GPR Amplitude Map Based on Top Bar Reflection for Bridge Deck A2111 with Superposed Core Locations and Visual Surface Condition Features

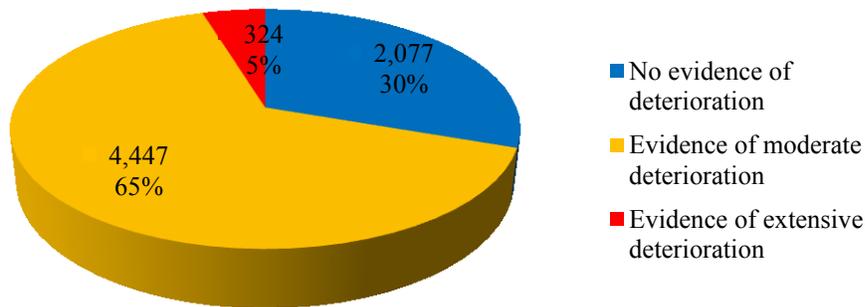
Figure 7-25 Graph Showing Predicted Distribution of Deterioration of the Bridge Deck A2111 in Each Category (Based on the Amplitude of the Reflection from the Top Layer of Rebar). Total Area Investigated - 6,848 ft²; No Evidence of Deterioration – 1,075 ft²; Evidence of Moderate Deterioration - 3,891 ft²; Evidence of Extensive Deterioration 274 ft².

Figure 7-25 shows that 30% of the area investigated on the bridge deck of Bridge A2111 exhibited no evidence of deterioration, 65% exhibited evidence of moderate deterioration, and 5% exhibited evidence of extensive deterioration based on the deterioration categories defined for the GPR amplitude results.

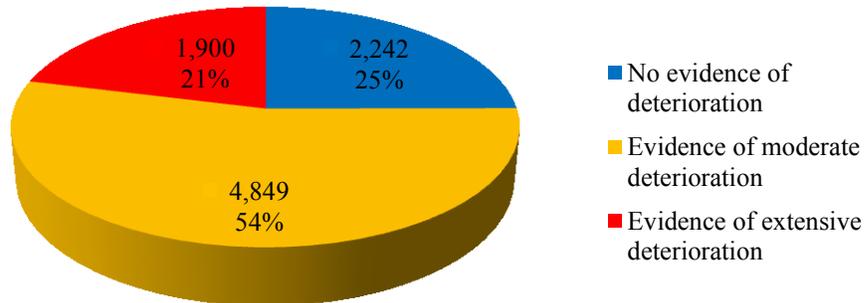
Figure 7-27 Graph Showing Predicted Distribution of Deterioration of the Bridge Deck A2966 in Each Category (Based on the Amplitude of the Reflection from the Top Layer of Rebar). Total Area Investigated - 8,991 ft²; No Evidence of Deterioration – 2,242 ft²; Evidence of Moderate Deterioration - 4,849 ft²; Evidence of Extensive Deterioration 1,900 ft².

Figure 7-27 shows that 25% of the area investigated on the bridge deck of Bridge A2966 exhibited no evidence of deterioration, 54% exhibited evidence of moderate deterioration, and 21% exhibited evidence of extensive deterioration based on the deterioration categories defined for the GPR amplitude results.

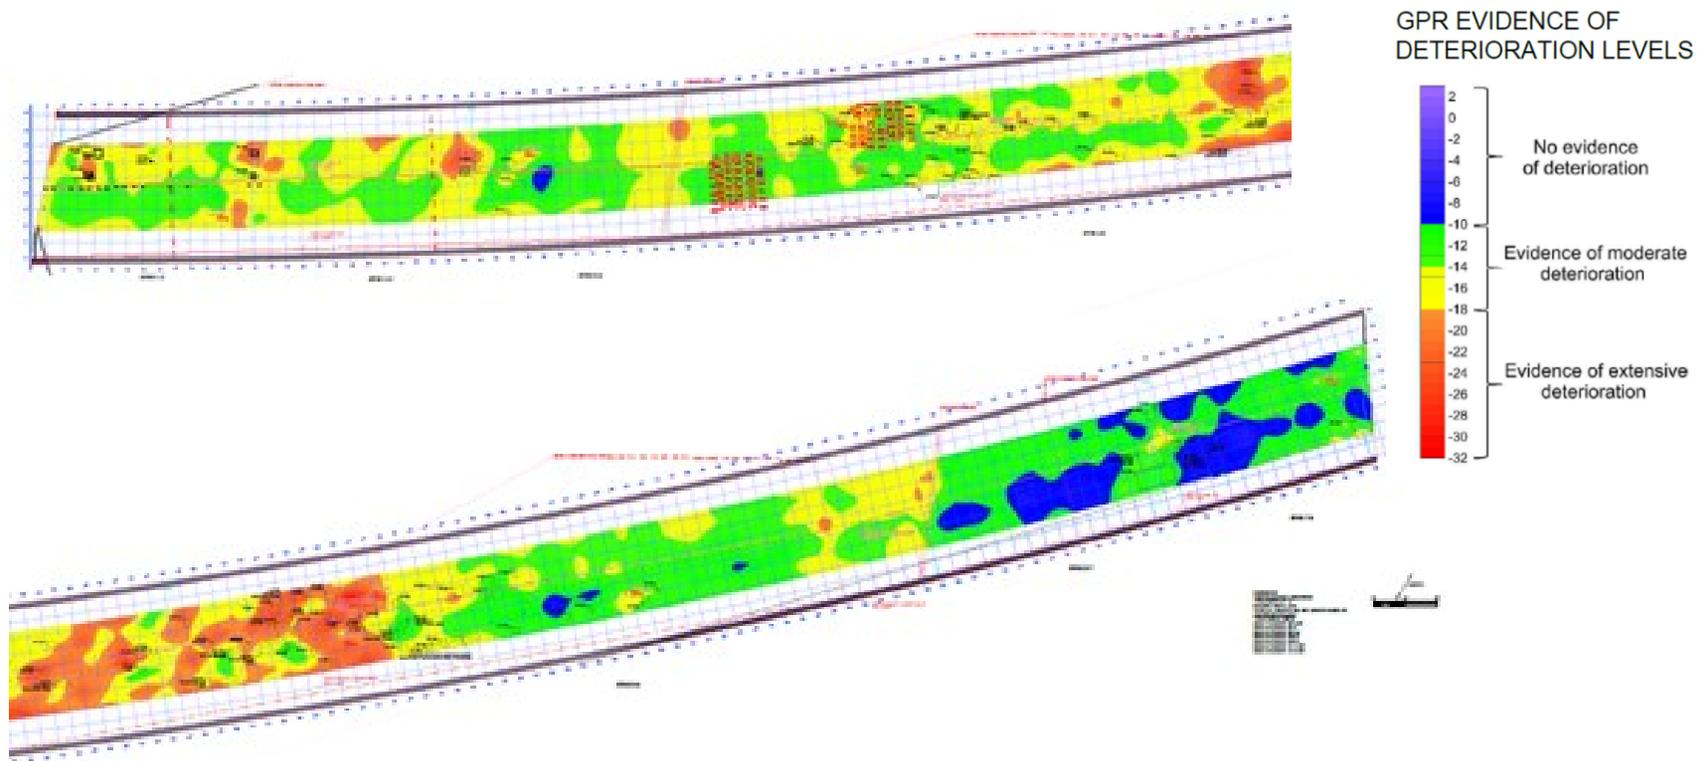
Figure 7-28 GPR Amplitude Map Based on Top Bar Reflection for Bridge Deck A3017 with Superposed Core Locations and Visual Surface Condition Features
