MISSOURI
S&T

CENTER FOR TRANSPORTATION INFRASTRUCTURE AND SAFETY

NONDESTRUCTIVE EVALUATION OF MODOT BRIDGE DECKS – PILOT STUDY

**NUTC
R311**

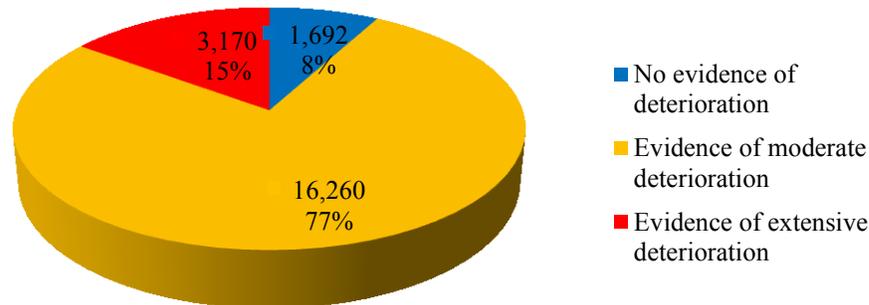
Figure 7-29 Graph Showing Predicted Distribution of Deterioration of the Bridge Deck A3017 in Each Category (Based on the Amplitude of the Reflection from the Top Layer of Rebar). Total Area Investigated - 21,122 ft²; No Evidence of Deterioration – 1,692 ft²; Evidence of Moderate Deterioration - 16,260 ft²; Evidence of Extensive Deterioration 3,170 ft².

Figure 7-29 shows that 8% of the area investigated on the bridge deck of Bridge A3017 exhibited no evidence of deterioration, 77% exhibited evidence of moderate deterioration, and 15% exhibited evidence of extensive deterioration based on the deterioration categories defined for the GPR amplitude results.

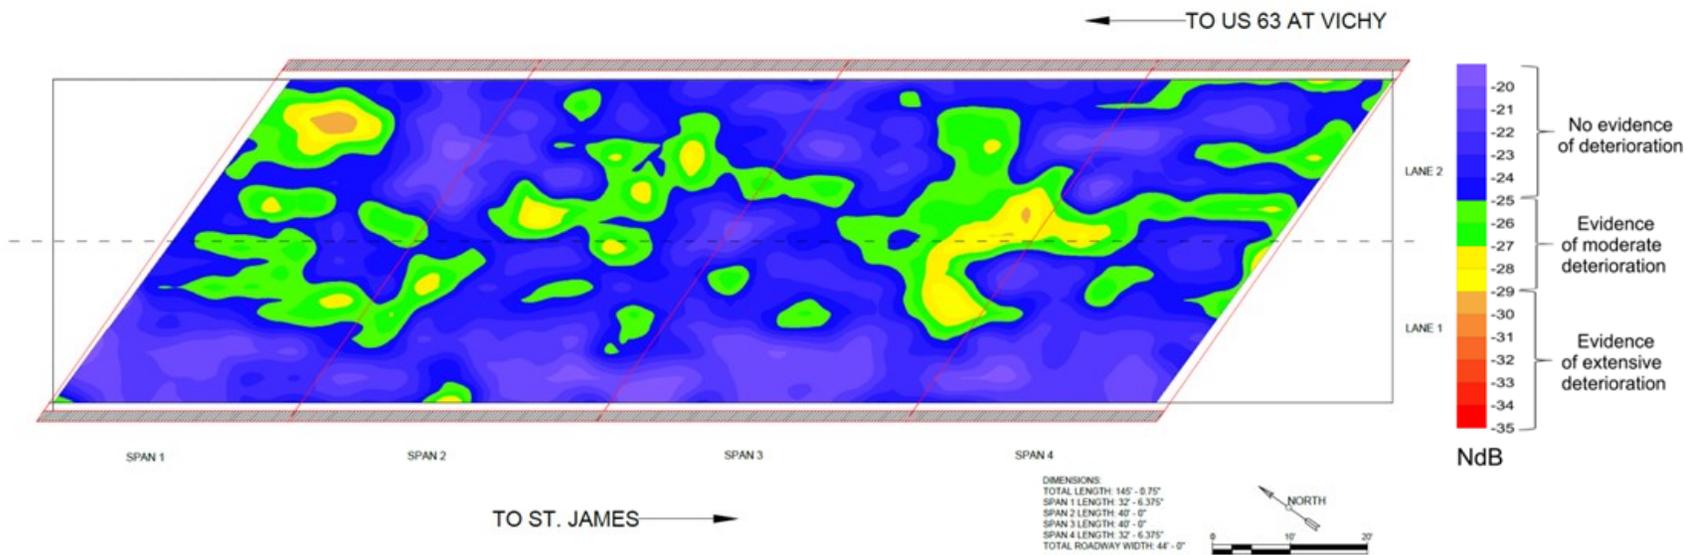
Figure 7-30 GPR Amplitude Map Based on Top Bar Reflection for Bridge Deck A3405 with Superposed Core Locations and Visual Surface Condition Features

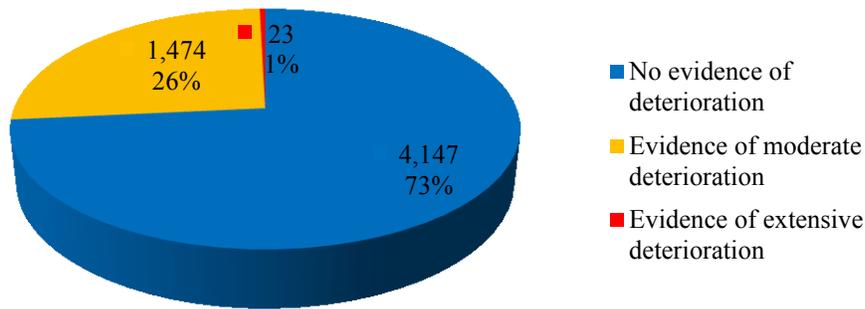
Figure 7-31 Graph Showing Predicted Distribution of Deterioration of the Bridge Deck A3405 in Each Category (Based on the Amplitude of the Reflection from the Top Layer of Rebar). Total Area Investigated - 5,644 ft²; No Evidence of Deterioration – 4,147 ft²; Evidence of Moderate Deterioration - 1,474 ft²; Evidence of Extensive Deterioration 23 ft².

Figure 7-31 shows that 73% of the area investigated on the bridge deck of Bridge A3405 exhibited no evidence of deterioration, 26% exhibited evidence of moderate deterioration, and 1% exhibited evidence of extensive deterioration based on the deterioration categories defined for the GPR amplitude results.

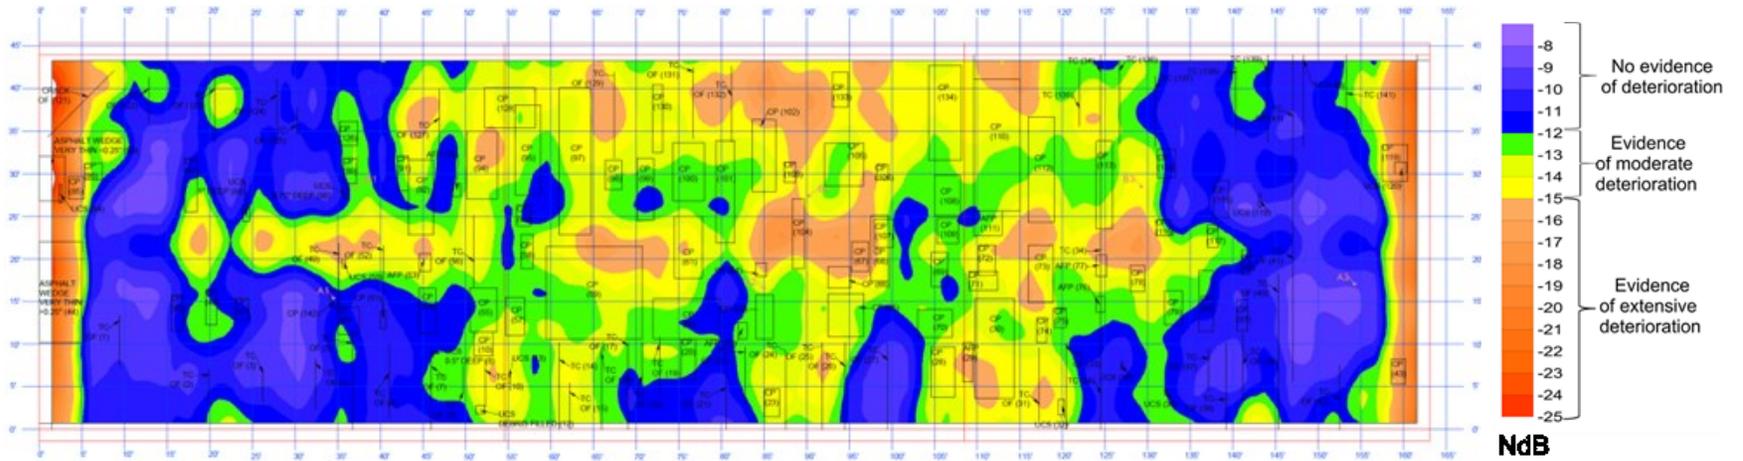
Figure 7-32 GPR Amplitude Map Based on Top Bar Reflection for Bridge Deck A3406 with Superposed Core Locations and Visual Surface Condition Features

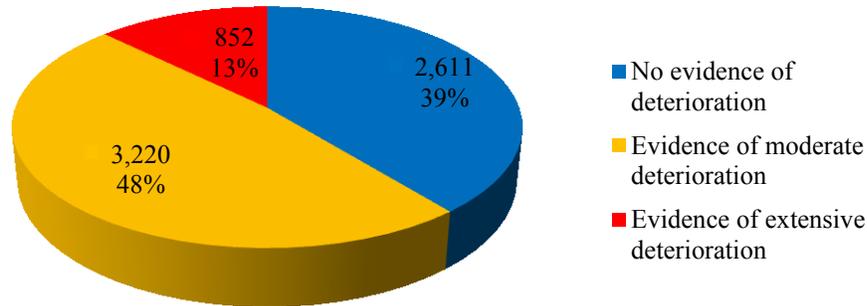
Figure 7-33 Graph Showing Predicted Distribution of Deterioration of the Bridge Deck A3406 in Each Category (Based on the Amplitude of the Reflection from the Top Layer of Rebar). Total Area Investigated - 6,683 ft²; No Evidence of Deterioration – 2,611 ft²; Evidence of Moderate Deterioration - 3,220 ft²; Evidence of Extensive Deterioration 852 ft².

Figure 7-33 shows that 39% of the area investigated on the bridge deck of Bridge A3406 exhibited no evidence of deterioration, 48% exhibited evidence of moderate deterioration, and 13% exhibited evidence of extensive deterioration based on the deterioration categories defined for the GPR amplitude results.

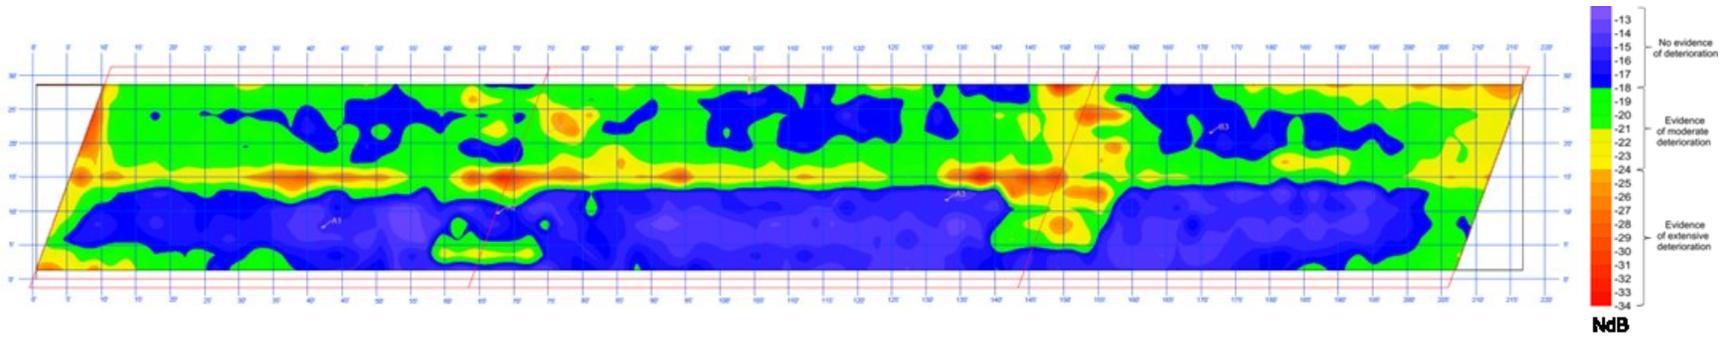
Figure 7-34 GPR Amplitude Map Based on Top Bar Reflection for Bridge Deck K0197 with Superposed Core Locations and Visual Surface Condition Features

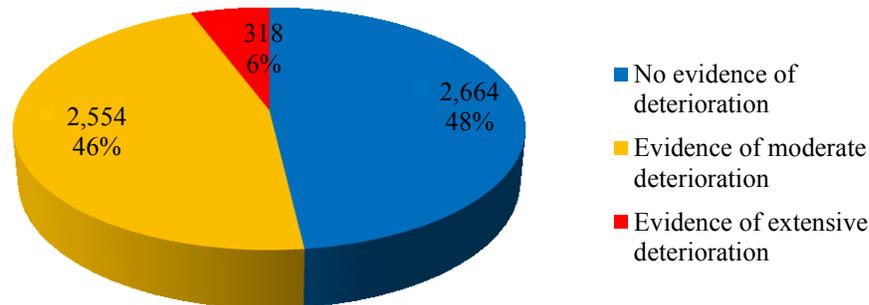
Bridge K0197

The GPR data were acquired along parallel traverses spaced at 1 ft intervals. The acquisition parameters employed were 512 samples/scan, 120 scans/second, and 48 scans/ft. The dielectric constant was assumed to be 10.0. A map of reflection amplitudes from the top layer of transverse rebar is shown in Figure 7-34. Amplitude ranges for three deterioration categories shown in Figure 7-34 were defined based on correlation of the GPR data with the visual evaluation of the cores. Area and percentage distribution of all three deterioration categories were calculated for the investigated bridge deck area and are shown in Figure 7-35.

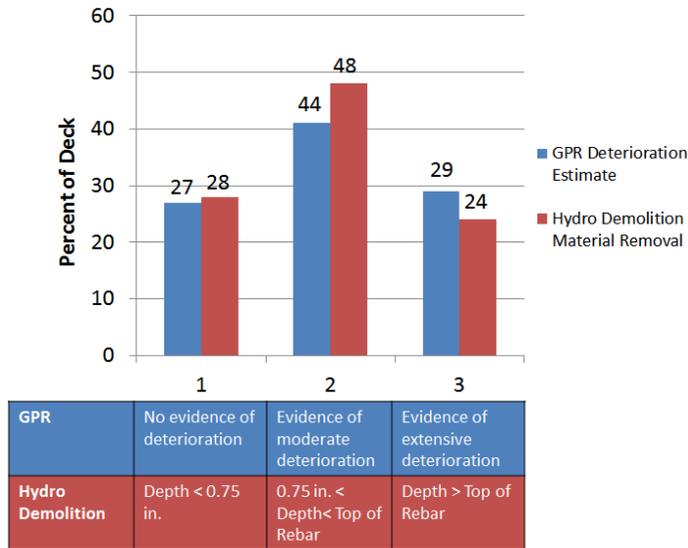
Considering the issues discussed in the previous paragraph, additional study was initiated to investigate the potential for improving the correlation between these two data sets. This process involved reevaluation of the amplitude ranges for defining the three GPR classifications by altering the threshold values, without consideration of other factors used in the initial interpretations of the data (e.g., visual evaluation data). Threshold values were artificially adjusted higher or lower until the best correlation between the GPR and the material removal percentages was achieved for each bridge deck. This work is ongoing at the time of this report, but preliminary results shown in Figures 7-36, 7-37, and 7-38 for Bridges A1193, A1297, and A1479, respectively, suggest that improved correlation is possible. Presently, a statistical approach is being used in an attempt to correlate the amplitude of the reflection with concrete removal depth for each data point for each of the three bridges. The major challenge, however, is to understand how to determine the GPR threshold values a priori, without having the benefit of the control data. Therefore, it should be noted that the results shown in Figures 7-36, 7-37, and 7-38 are not predictive.

Figure 7-37 Percentage of Bridge Deck Area for Bridge A1297 Categorized by GPR Results with adjusted threshold levels and Rehabilitation Lidar Survey

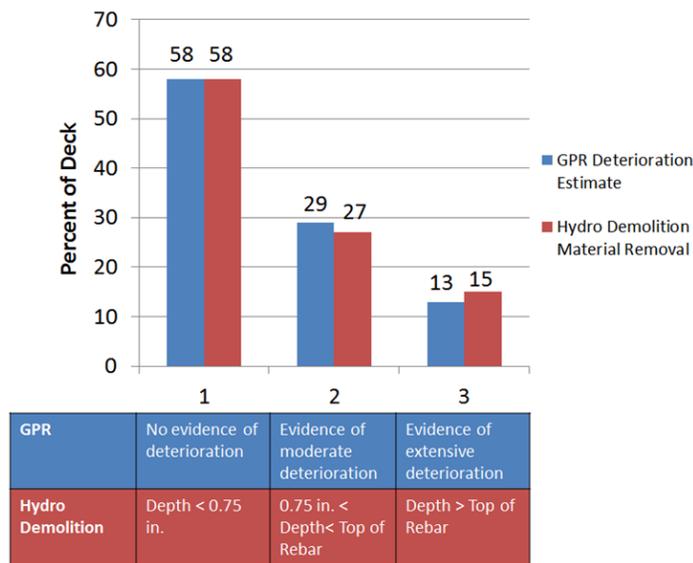
Figure 7-38 Percentage of Bridge Deck Area for Bridge A1479 Categorized by GPR Results with adjusted threshold levels and Rehabilitation Lidar Survey

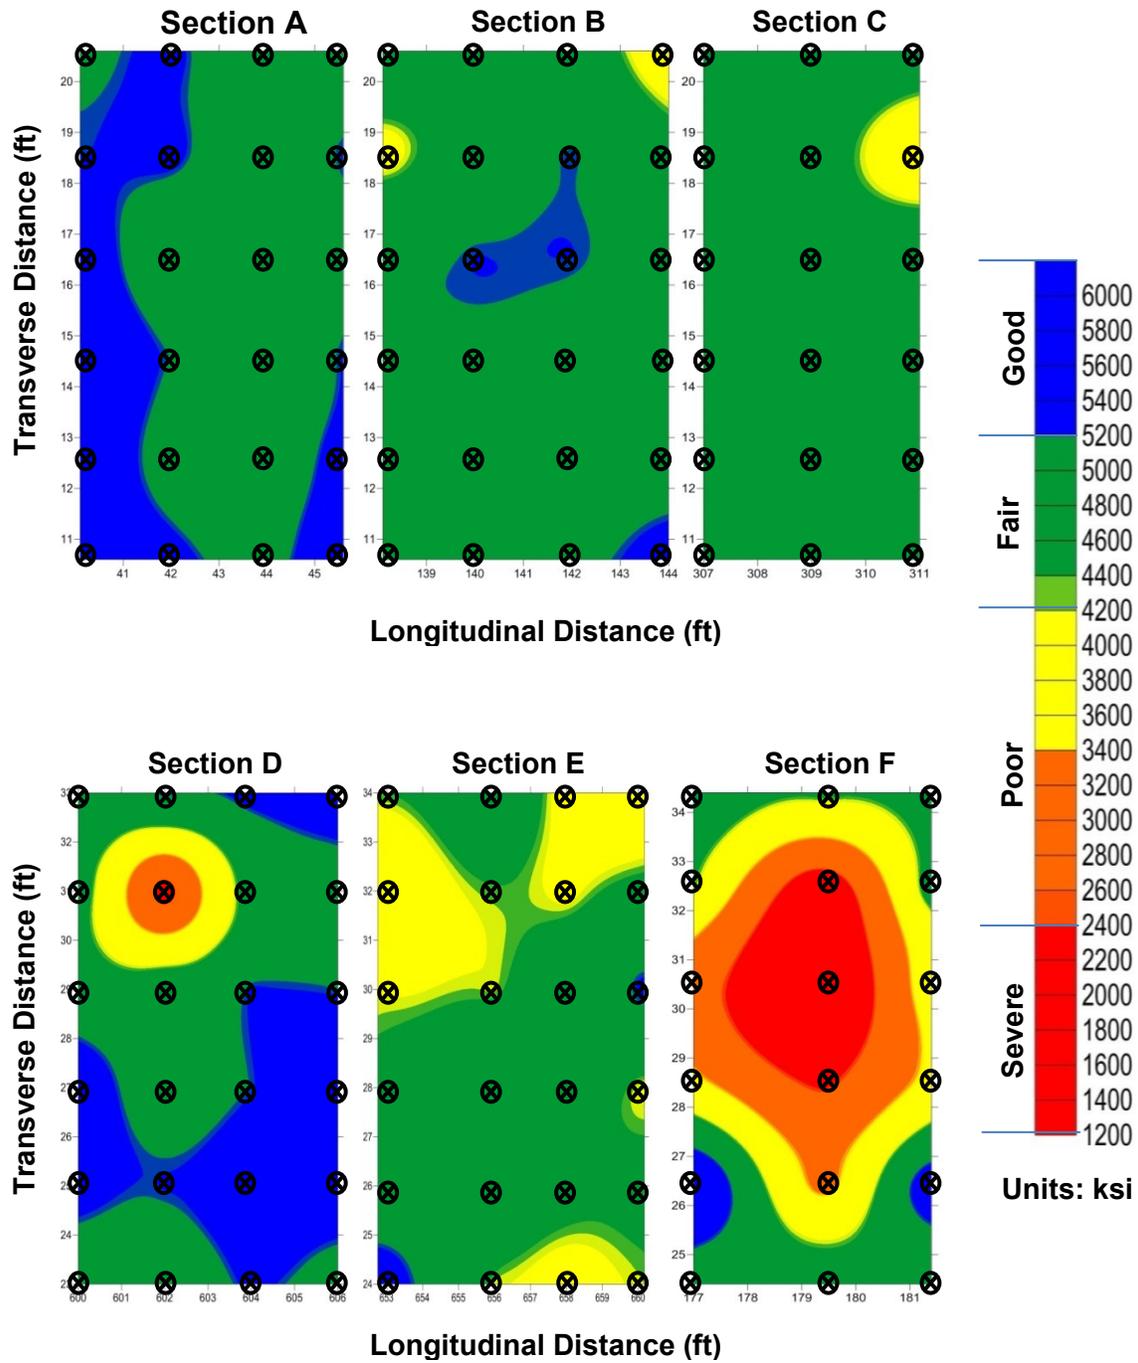
Figure 8-7 Bridge A1193 map of average elastic modulus (Young's Modulus) values for each PSPA section

Of the 141 test points acquired on Bridge A1193, 19% of the PSPA test points located in the USW map (Figure 8-7) indicate concrete deterioration (Poor or Severe condition). 8% of the PSPA test points located in the IE map (Figure 8-8) indicate concrete deterioration (Poor or Severe condition). To determine correlation with other data sets, the PSPA USW results are compared to the hydrodemolition and GPR data sets in Figures 8-9 and 8-10. 15% of the PSPA test points located in lidar map (Figure 8-9) indicate concrete deterioration (warm color). 34% of PSPA test points located in GPR map (Figure 8-10) indicate moderate concrete deterioration (warm color). The correlation of the PSPA results is good between the USW and hydrodemolition results. The correlation of PSPA results is fair between USW and GPR results.

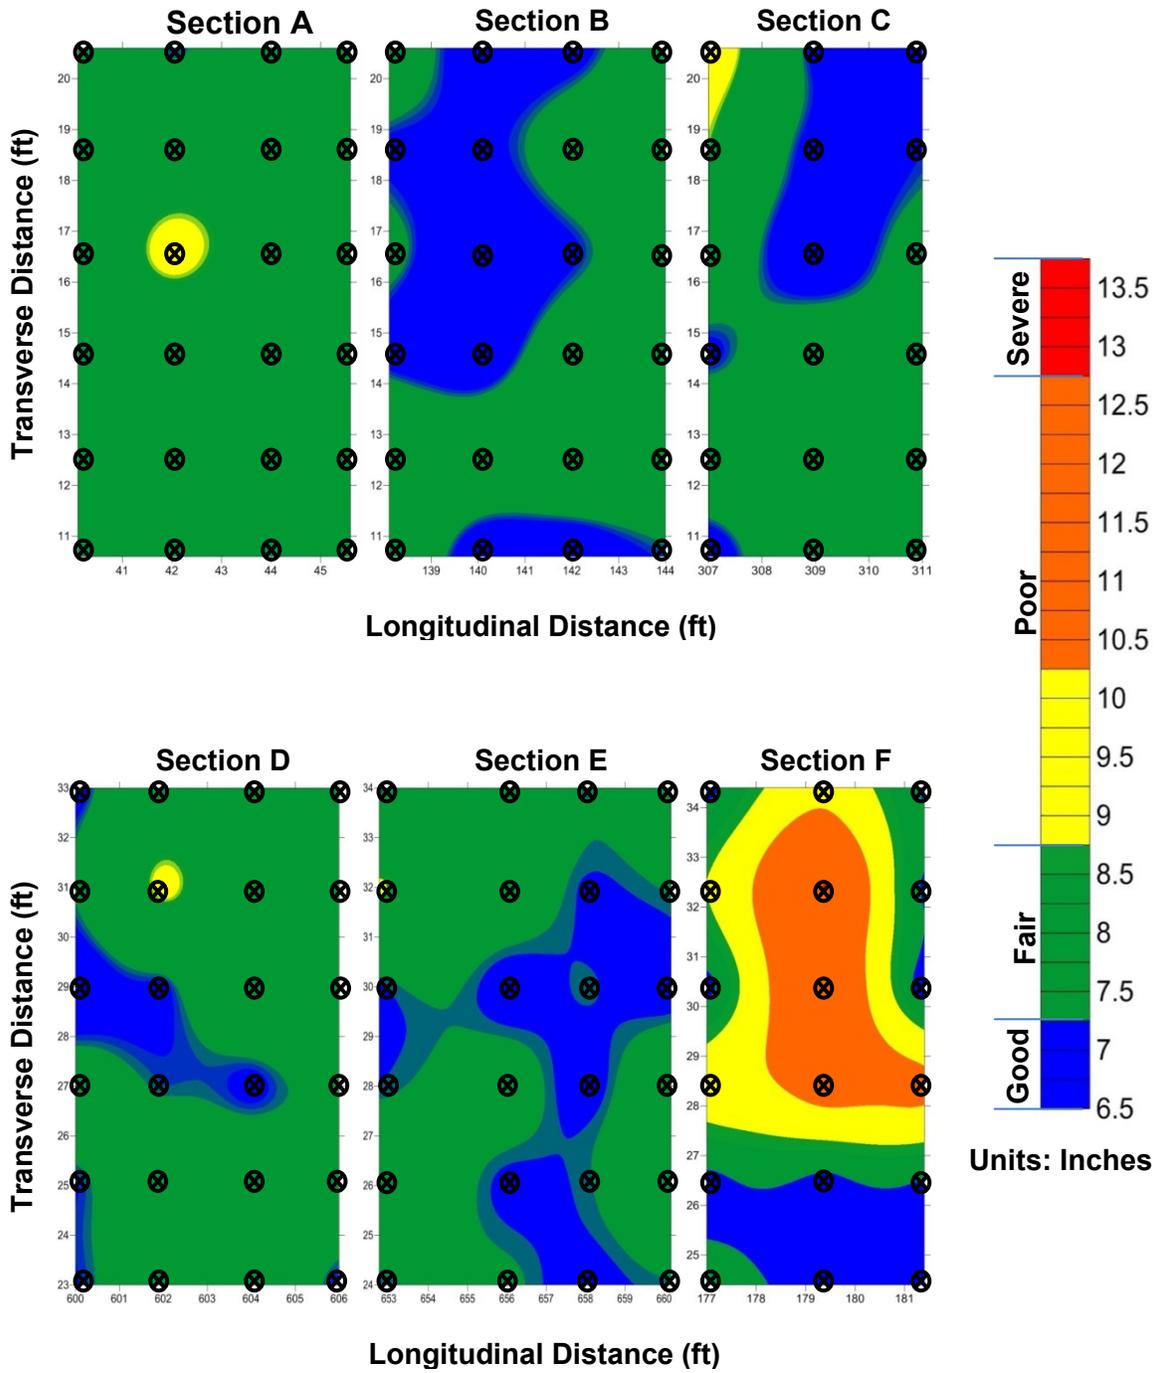
Figure 8-8 Bridge A1193 apparent depth map for each PSPA section

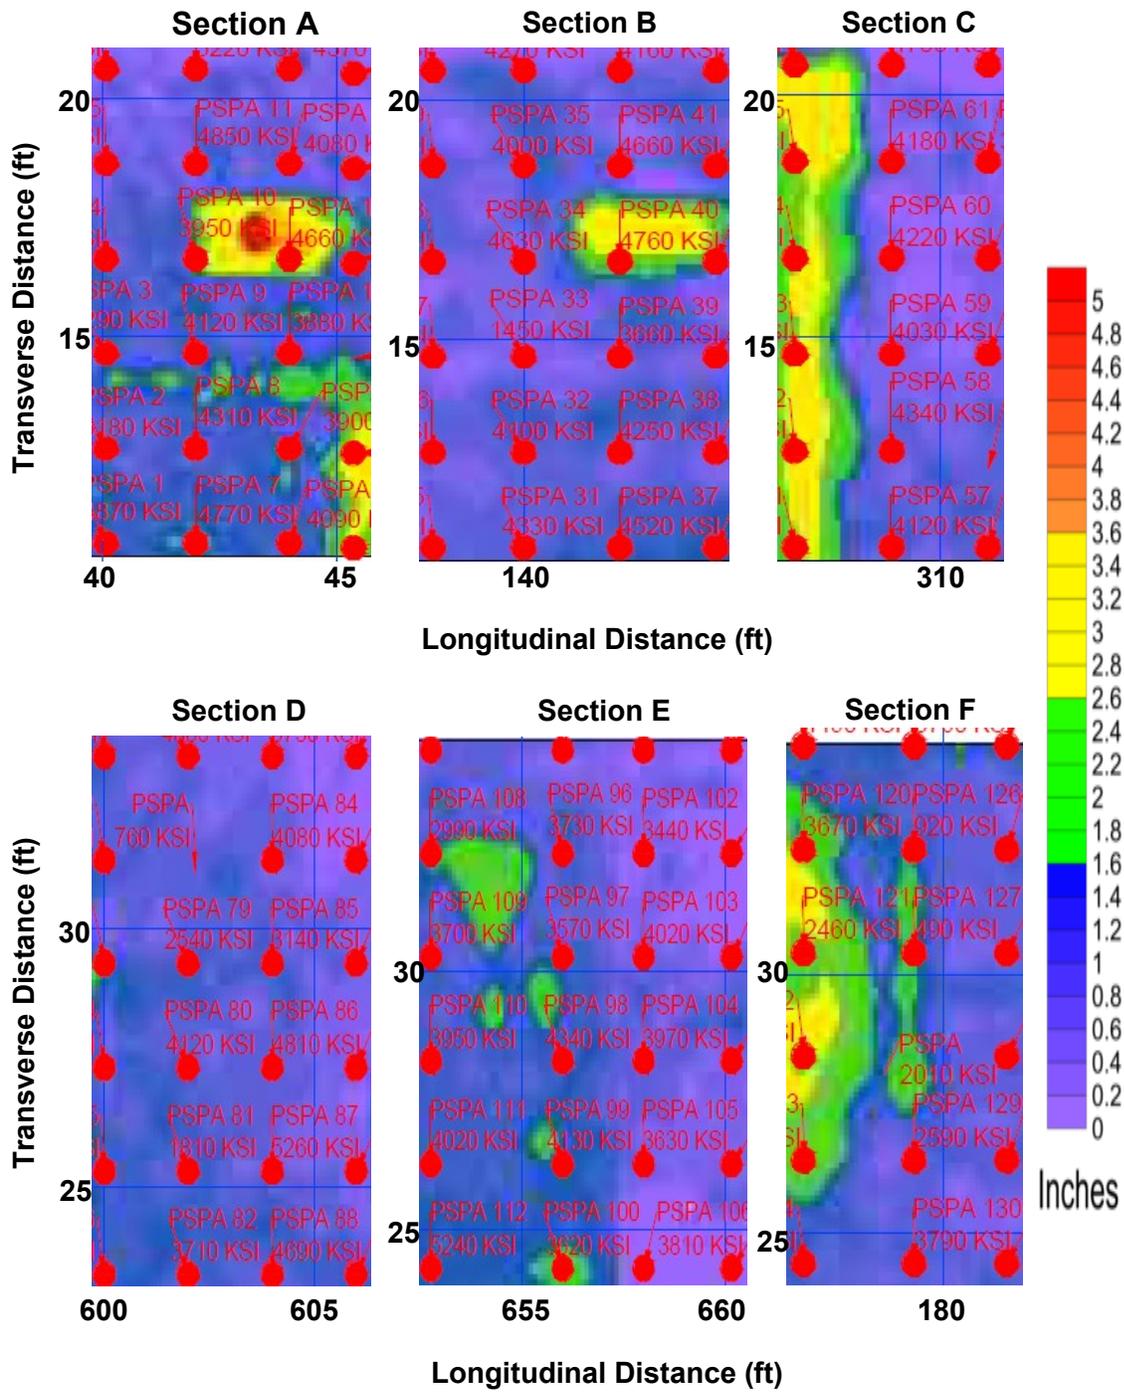
Figure 8-9 Bridge 1193 lidar data superposed with PSPA test points

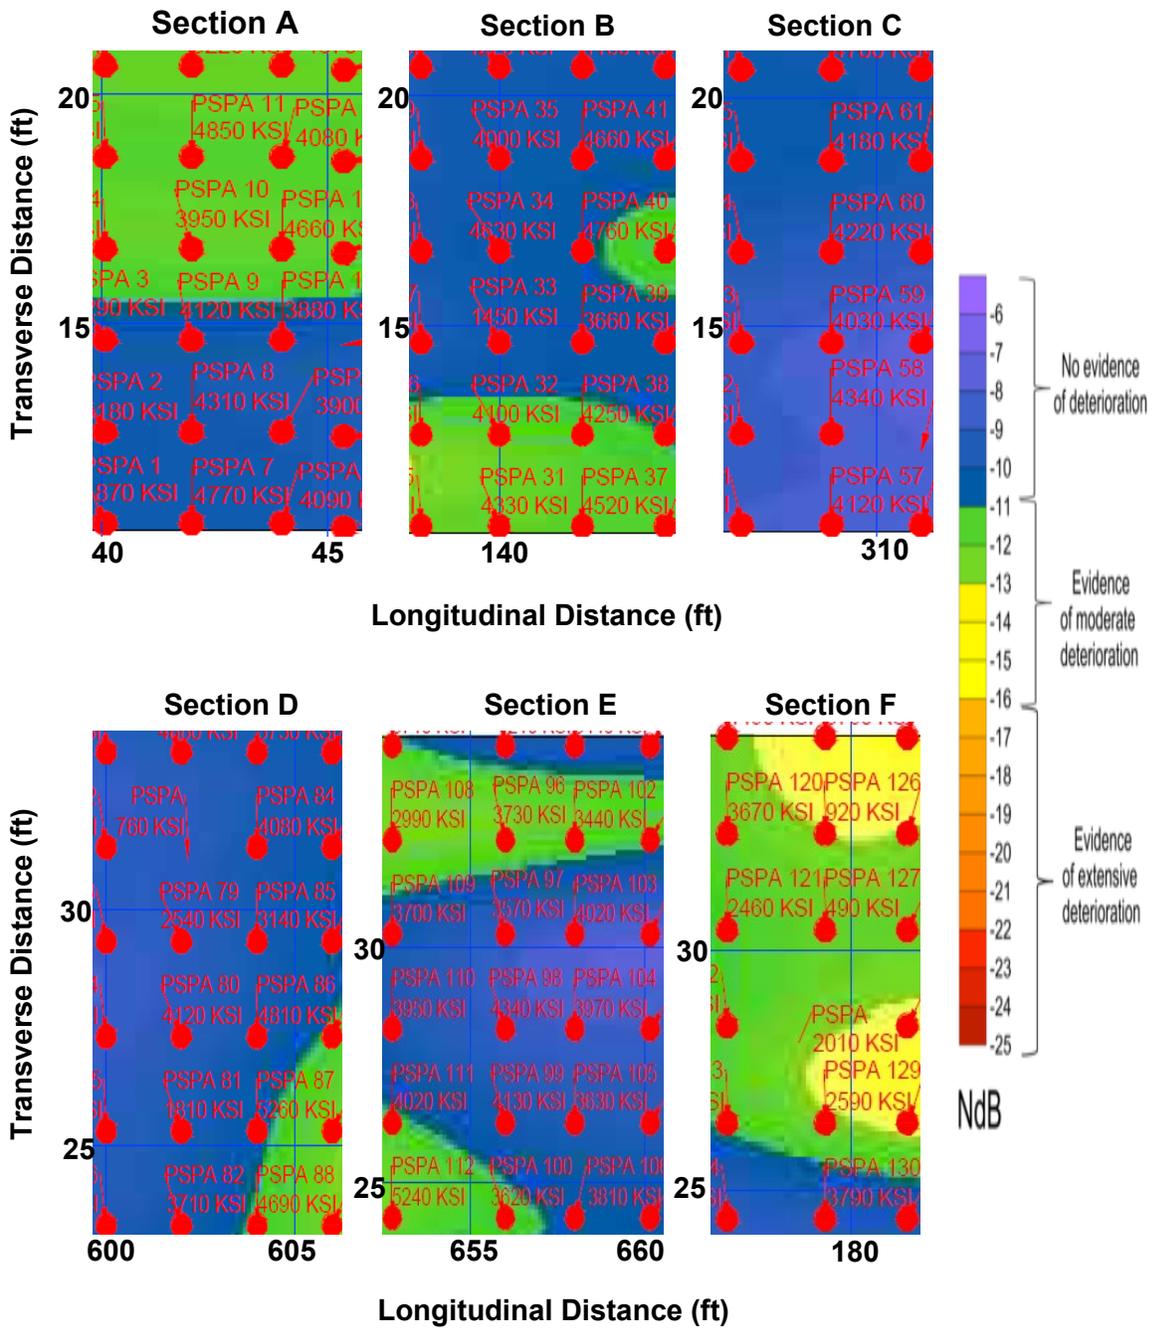
Figure 8-10 Bridge 1193 GPR data superposed with PSPA test points

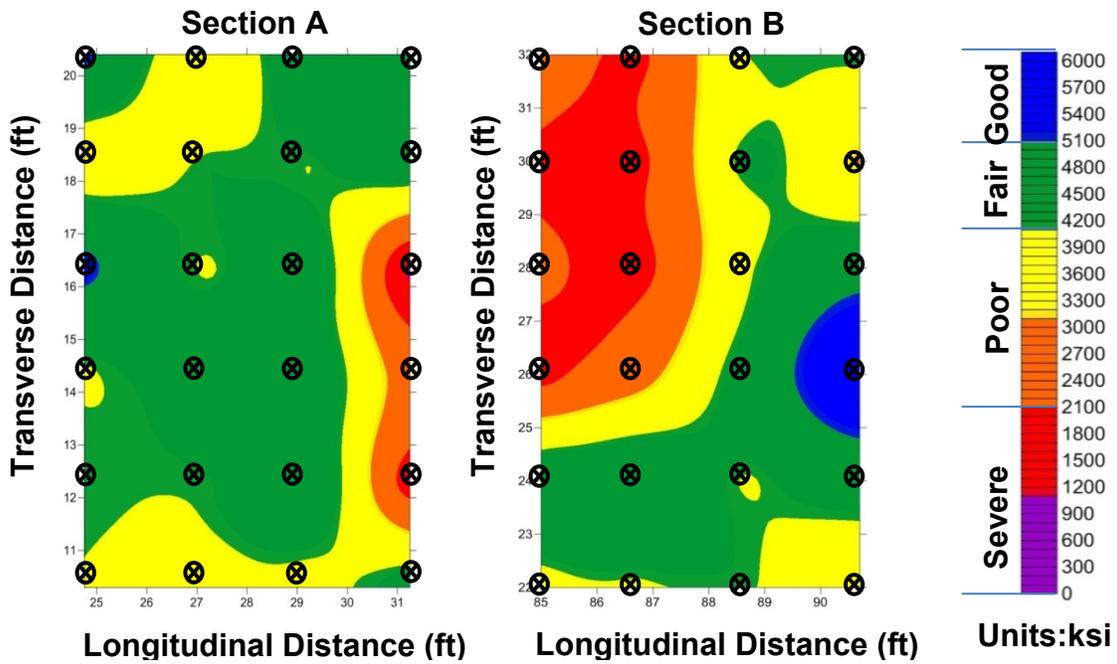
Figure 8-12 Bridge A1297 map of average elastic modulus (Young's Modulus) values for each PSPA section

Of the 56 test points acquired on Bridge A1297, 56% of the PSPA test points located in the USW map (Figure 8-12) indicate concrete deterioration (Poor or Severe condition). 33% of the PSPA test points located in the IE map (Figure 8-13) indicate concrete deterioration (Poor or Severe condition). To determine correlation with other data sets, the PSPA USW results are compared to the hydrodemolition and GPR data sets in Figures 8-14 and 8-15. 48% of the PSPA test points located in lidar map (Figure 8-14) indicate concrete deterioration (warm color). 70% of PSPA test points located in GPR map (Figure 8-15) indicate moderate concrete deterioration (warm color). The correlation of the PSPA results is good between the USW and hydrodemolition results. The correlation of PSPA results is fair between USW and GPR results.

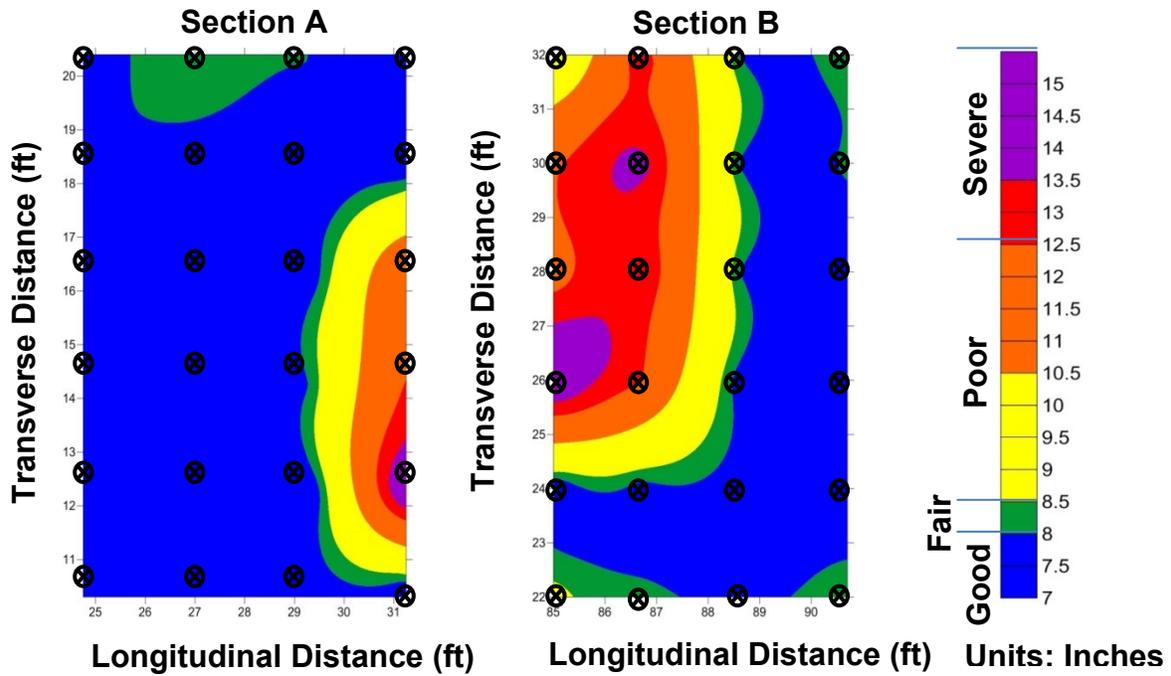
Figure 8-13 Bridge A1297 apparent depth map for each PSPA section

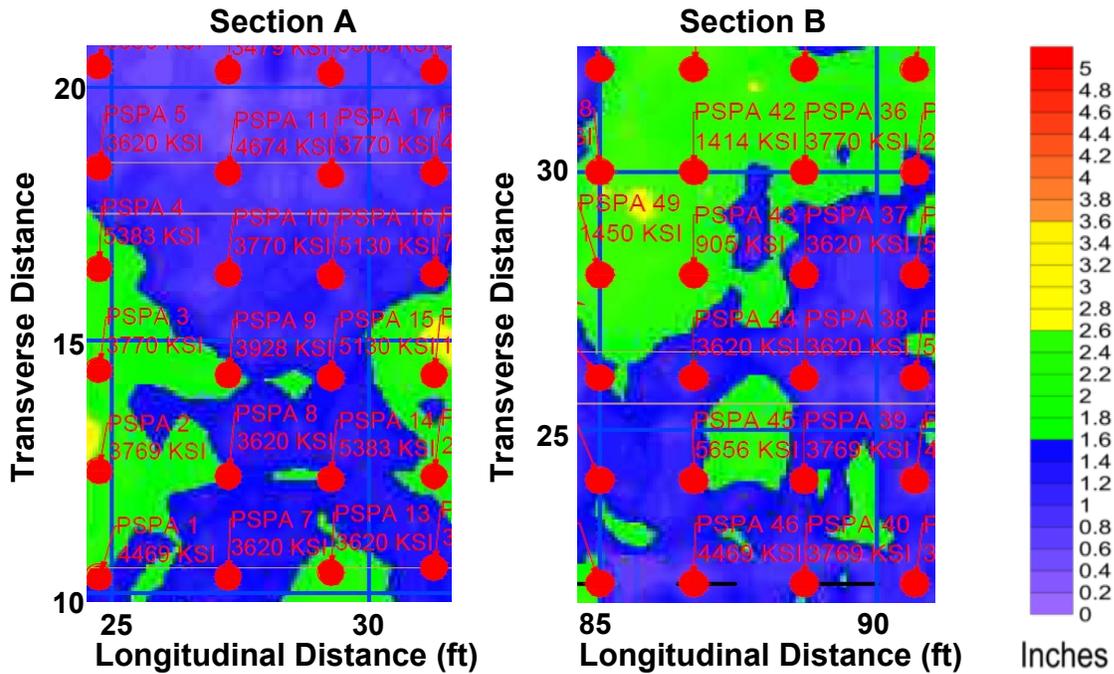
Figure 8-14 Bridge 1297 lidar data superposed with PSPA test points

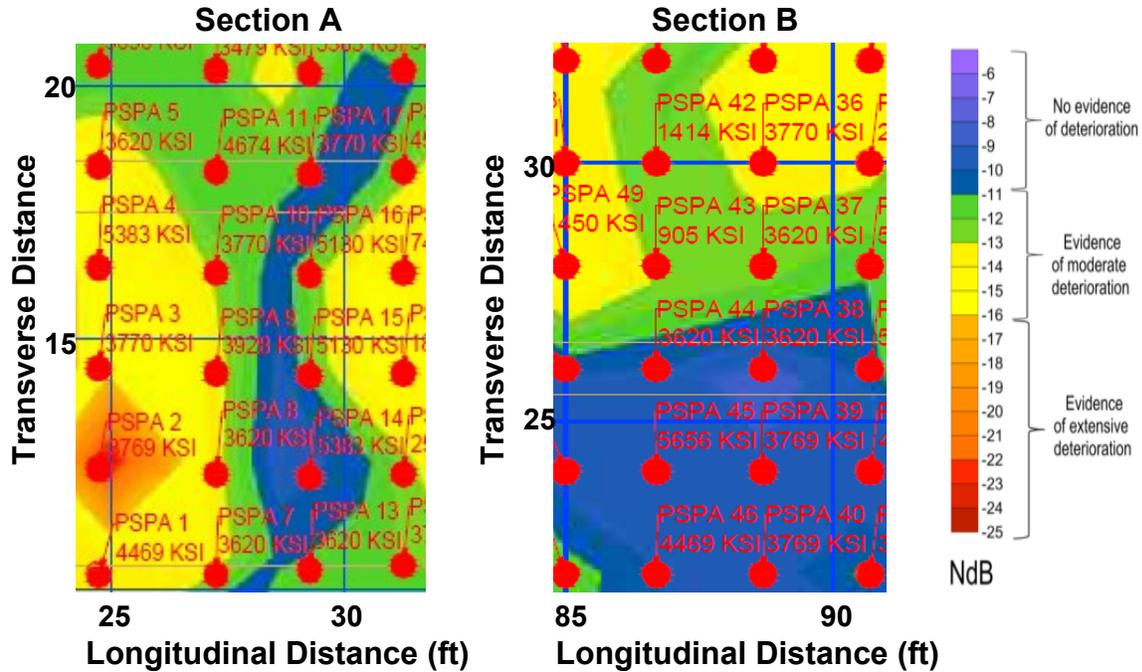
Figure 8-15 Bridge 1297 GPR data superposed with PSPA test points

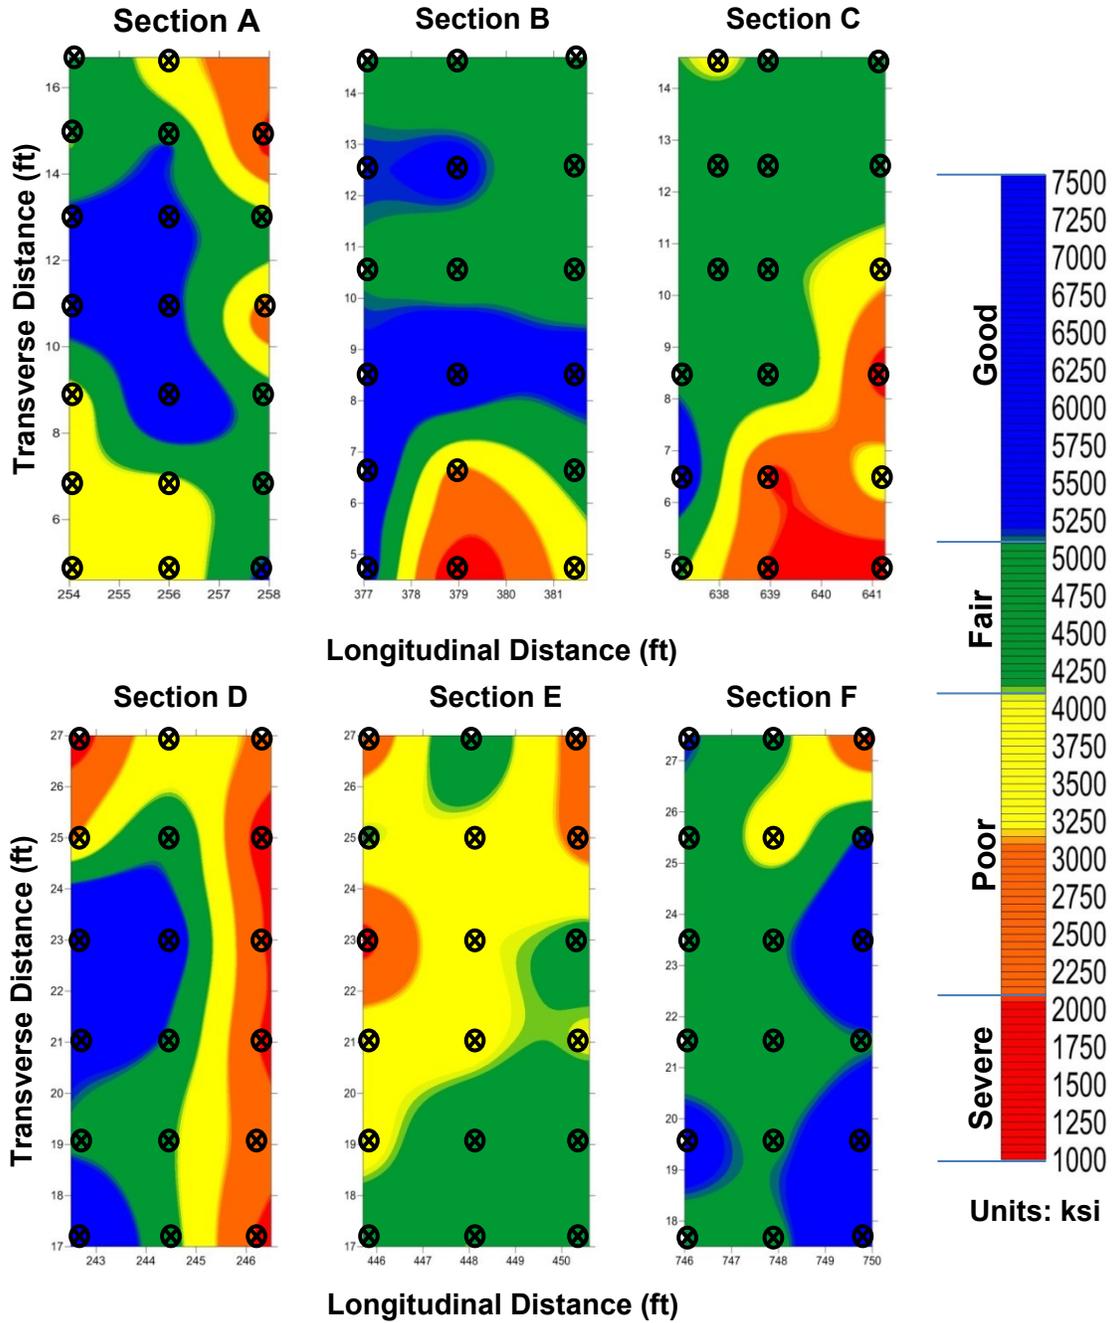
Figure 8-17 Bridge A1479 map of average elastic modulus (Young's Modulus) values for each PSPA section

Of the 120 test points acquired on Bridge A1479, 35% of the PSPA test points located in the USW map (Figure 8-17) indicate concrete deterioration (Poor or Severe condition). 17% of the PSPA test points located in the IE map (Figure 8-18) indicate concrete deterioration (Poor or Severe condition). To determine correlation with other data sets, the PSPA USW results are compared to the hydrodemolition and GPR data sets in Figures 8-19 and 8-20. 38% of the PSPA

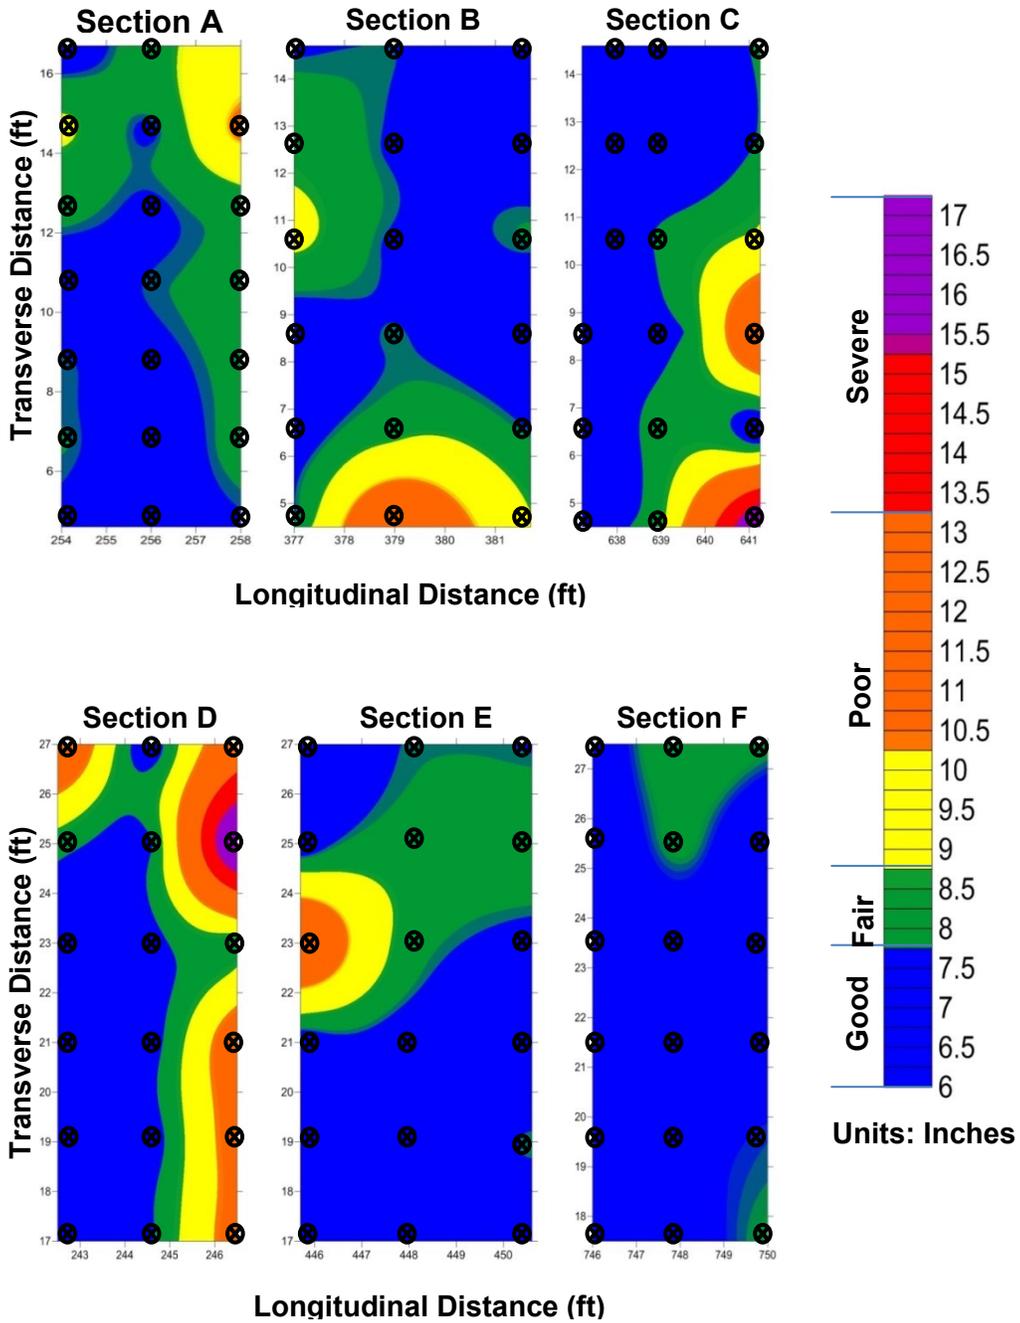
Figure 8-18 Bridge A1479 apparent depth map for each PSPA section

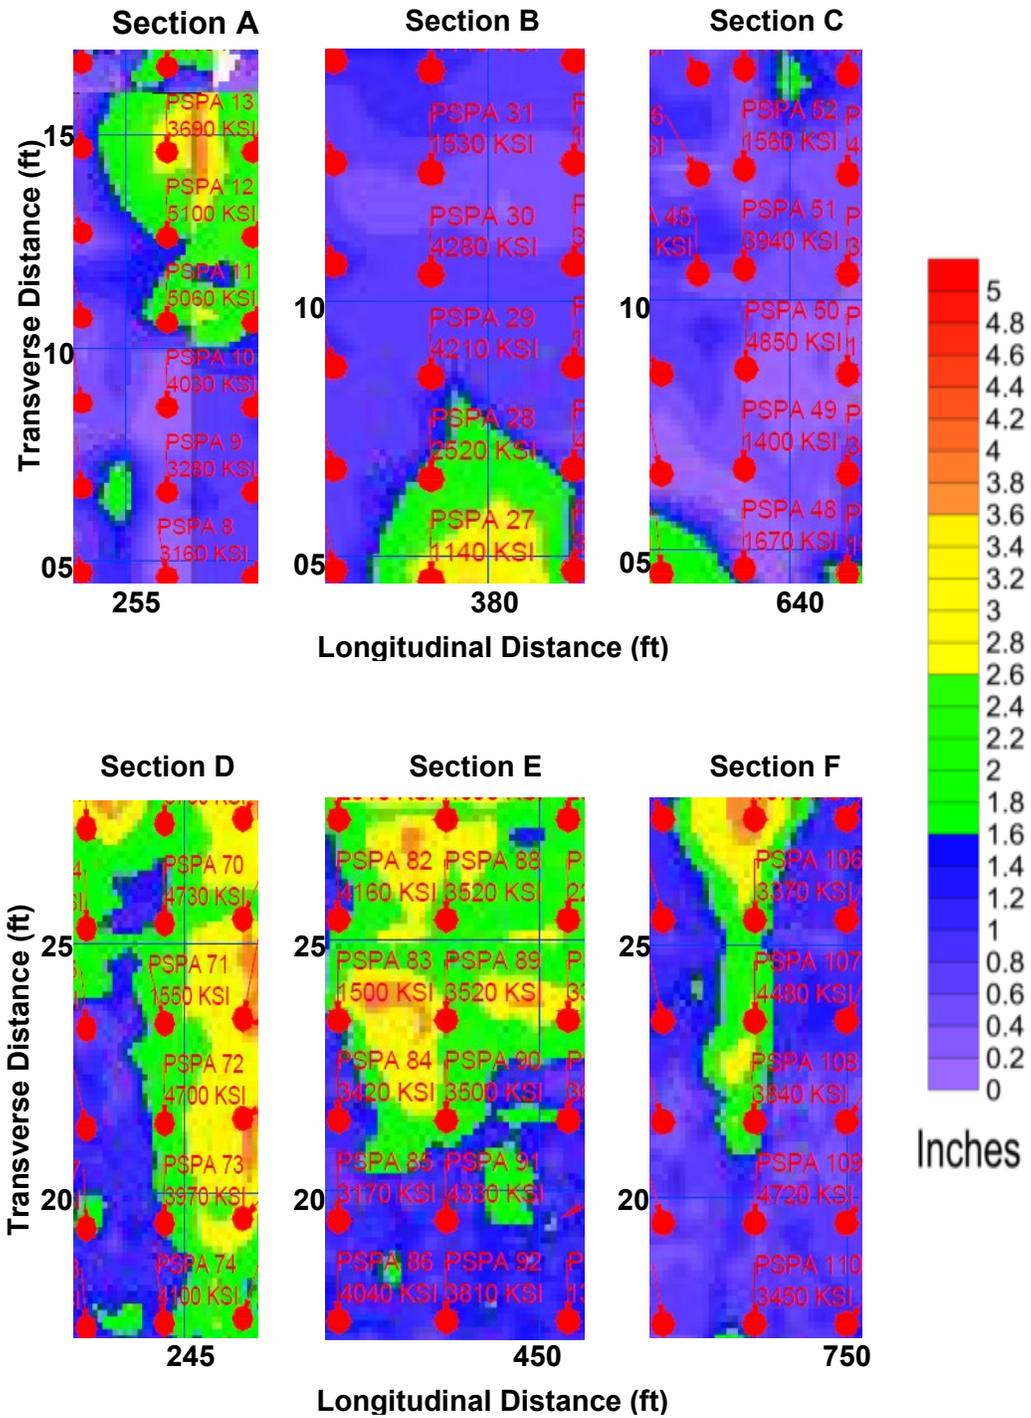
Figure 8-19 Bridge A1479 lidar data superposed with PSPA test points

test points located in lidar map (Figure 8-19) indicate concrete deterioration (warm color). 72% of PSPA test points located in GPR map (Figure 8-20) indicate moderate concrete deterioration (warm color). The correlation of the PSPA results is good between the USW and hydrodemolition results. The correlation of PSPA results is poor between USW and GPR results.

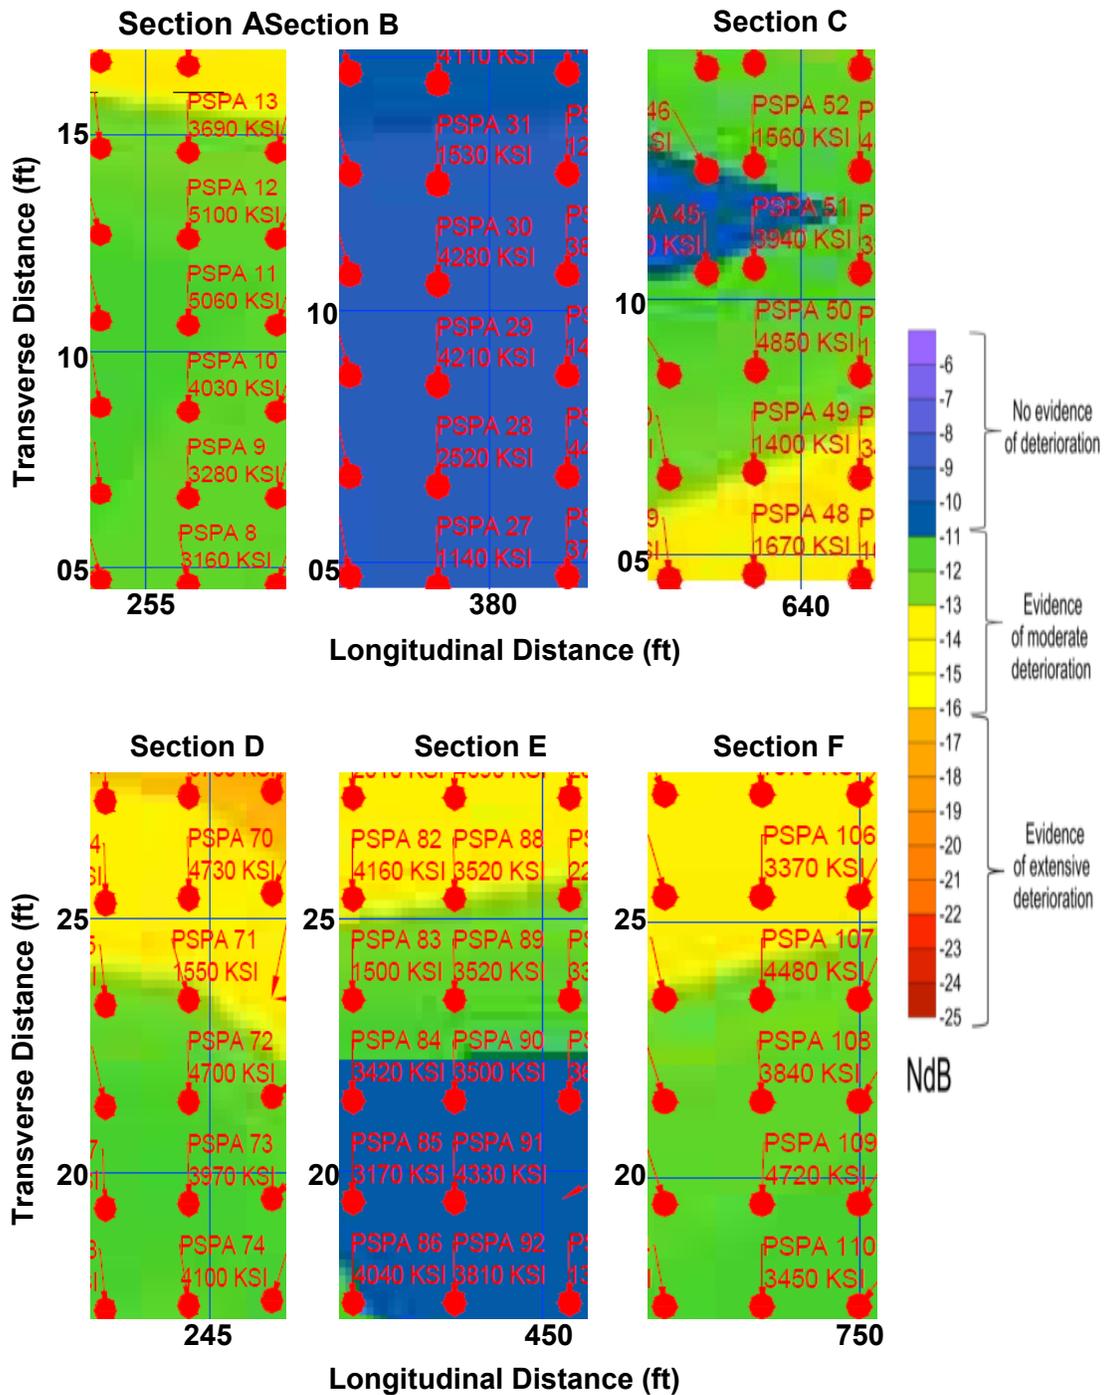
Figure 8-20 Bridge A1479 GPR data superposed with PSPA test points
