VALIDATION OF FRP COMPOSITE TECHNOLOGY THROUGH FIELD TESTING

Strengthening of Bridge T-0530 Crawford County, MO

Feb 19, 2004

Strengthening of Bridge T-0530

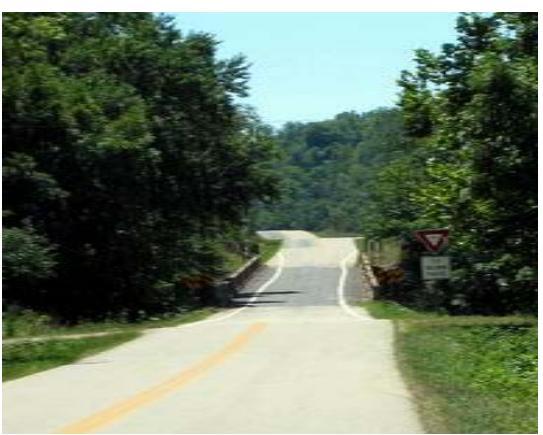
Figure 1. Approach to the bridge

Bridge T-0530 is located in Crawford County, MoDOT District 9. The structure has five equally-spaced spans (47 ft, 14.33 m), each with four RC girders monolithically cast on a 6 in (15 cm) slab (see Table 1, Figure 1, Figure 2 and Figure 3). The total bridge length is 237 *ft* (72.23 m) and the total width of the deck is 23 f t(7 m). Each span has one transversal beam with the same depth as the main girders (Figure 2).

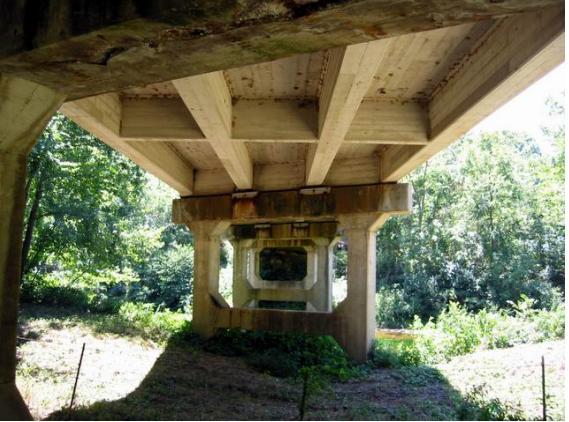
Figure 2. Longitudinal and transversal beams

- Height of the bridge is 23 ft (7 m). Total width of deck is 23 ft (7 m).
- Deck consists of four RC beams spaced 78 in (2m) on centers. All spans have also a transverse beams (Figure 2). The thickness of the slab is 6 in (15 cm).
