Determining the Depth of Hydro Demolition using Lidar Methods

**NUTC
R334**

1. Report No. NUTC R334	2. Government Accession No.	3. Recipient's Catalog No.	
4. Title and Subtitle Determining the Depth of Hydro Demolition using Lidar Methods		5. Report Date February 2014

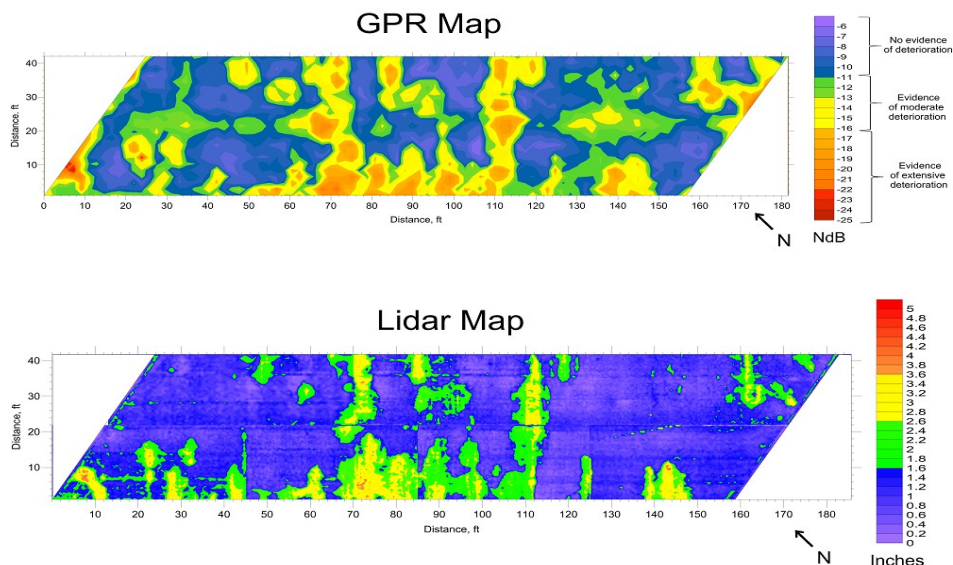
The GPR predictive maps generally agreed with the Lidar-based ground truth data. The best correlation was achieved on the Union Pacific Railroad bridge:

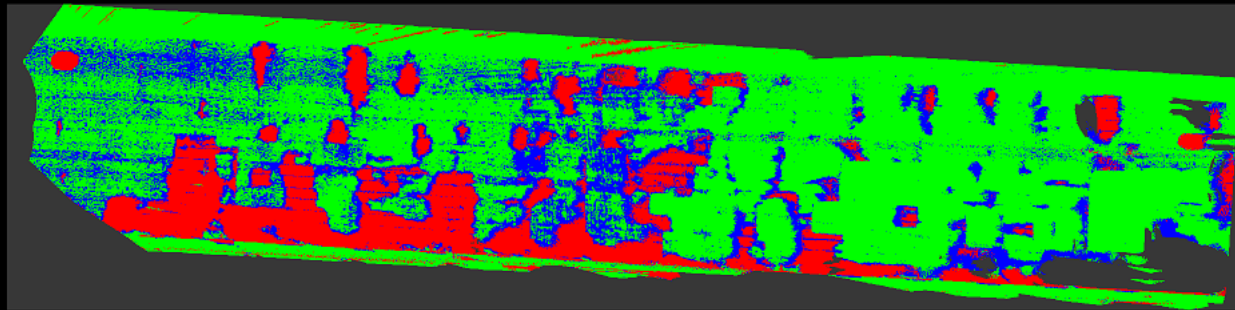
Depth of Hydro demolition (difference from original surface)
Segment 204

Green: Depth of 3/4 inch or less
Blue: Depth of 3/4 inch to Top of Rebar
Red: Deeper than Top of Rebar

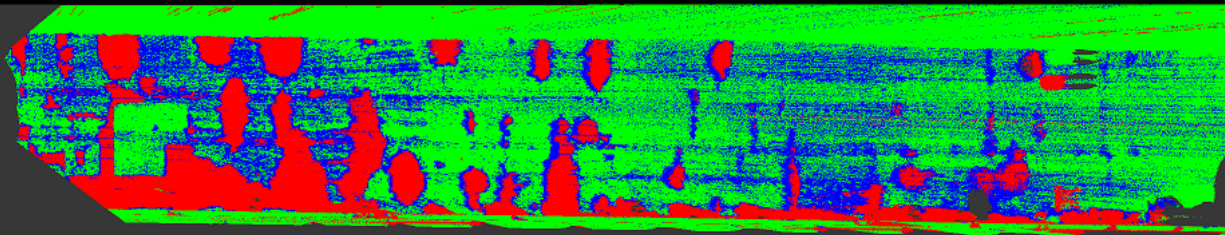
Depth of Hydro demolition (difference from original surface)
Segment 205

Green: Depth of 3/4 inch or less
Blue: Depth of 3/4 inch to Top of Rebar
Red: Deeper than Top of Rebar

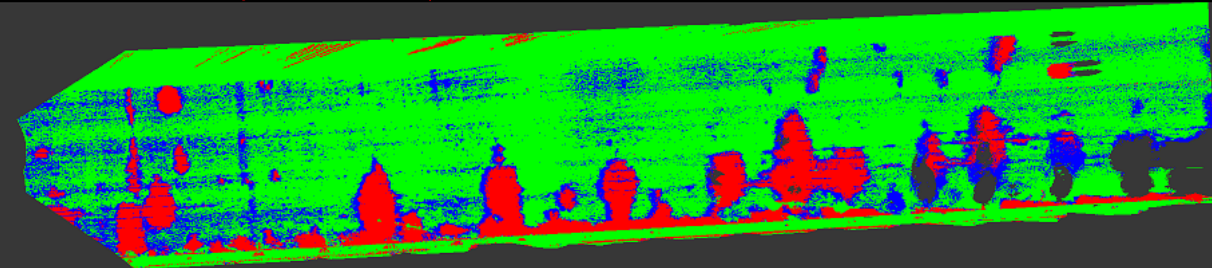
Depth of Hydro demolition (difference from original surface)
Segment 206

Green: Depth of 3/4 inch or less
Blue: Depth of 3/4 inch to Top of Rebar
Red: Deeper than Top of Rebar

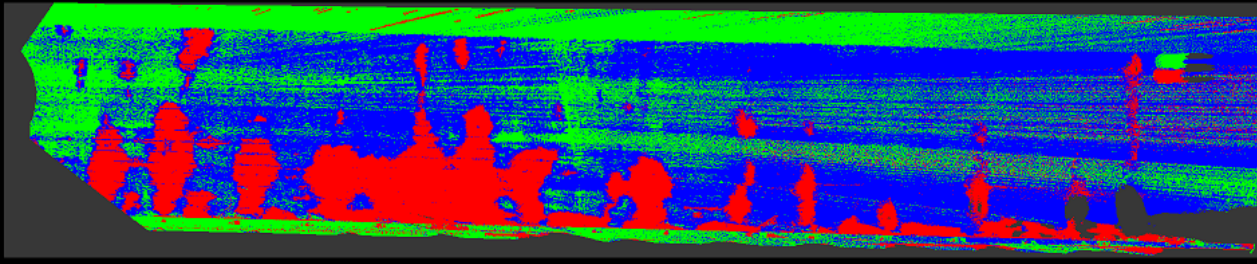
Depth of Hydro demolition (difference from original surface)
Segment 207

Green: Depth of 3/4 inch or less
Blue: Depth of 3/4 inch to Top of Rebar
Red: Deeper than Top of Rebar

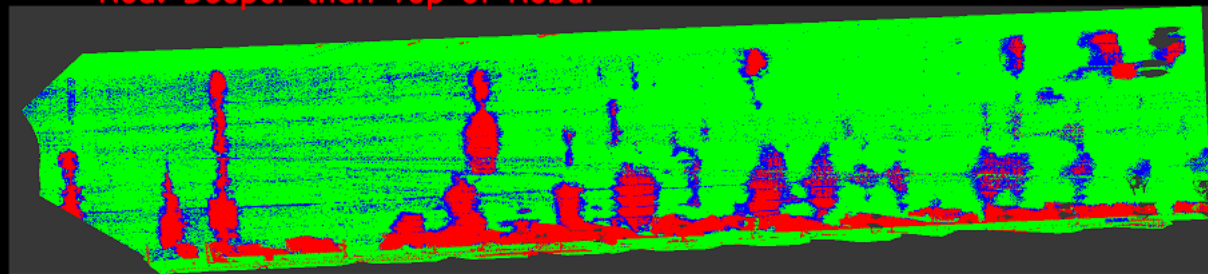
Depth of Hydro demolition (difference from original surface)
Segment 208

Green: Depth of 3/4 inch or less
Blue: Depth of 3/4 inch to Top of Rebar
Red: Deeper than Top of Rebar

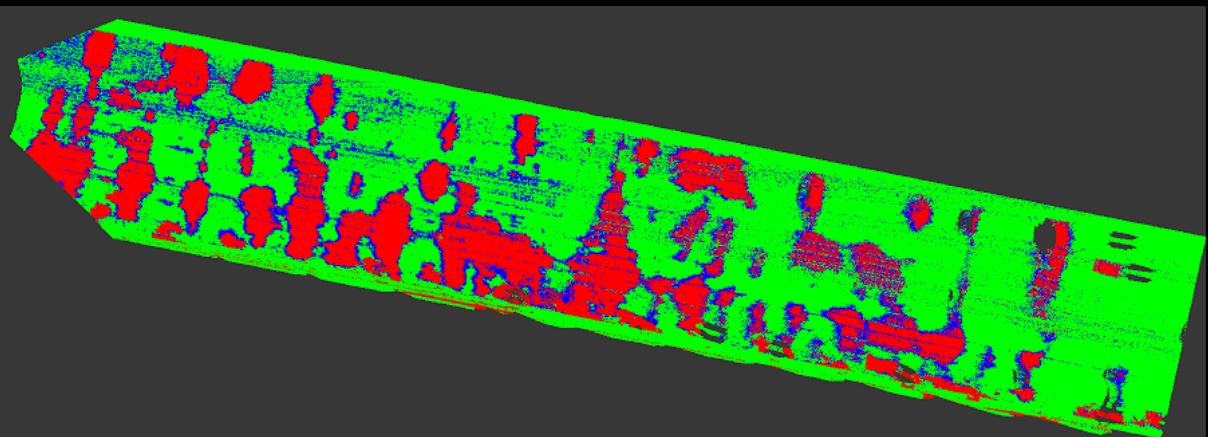
Depth of Hydro demolition (difference from original surface)
Segment 209

Green: Depth of 3/4 inch or less
Blue: Depth of 3/4 inch to Top of Rebar
Red: Deeper than Top of Rebar

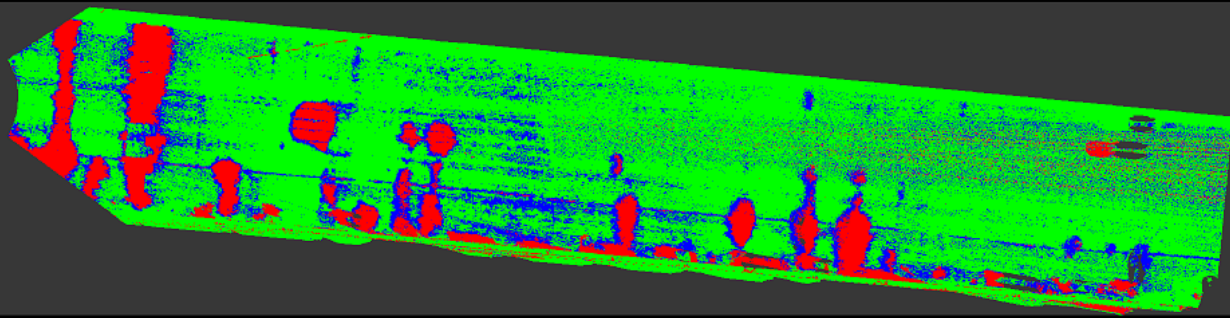
Depth of Hydro demolition (difference from original surface)
Segment 210

Green: Depth of 3/4 inch or less
Blue: Depth of 3/4 inch to Top of Rebar
Red: Deeper than Top of Rebar

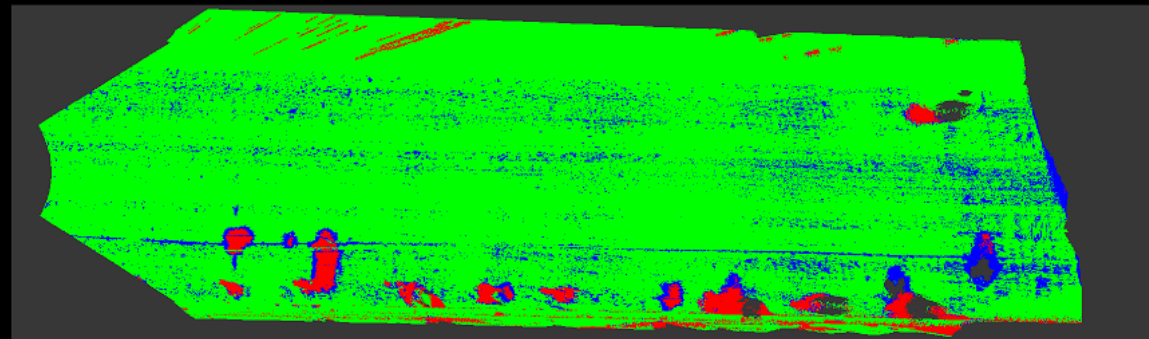
Depth of Hydro demolition (difference from original surface)
Segment 211

Green: Depth of 3/4 inch or less
Blue: Depth of 3/4 inch to Top of Rebar
Red: Deeper than Top of Rebar

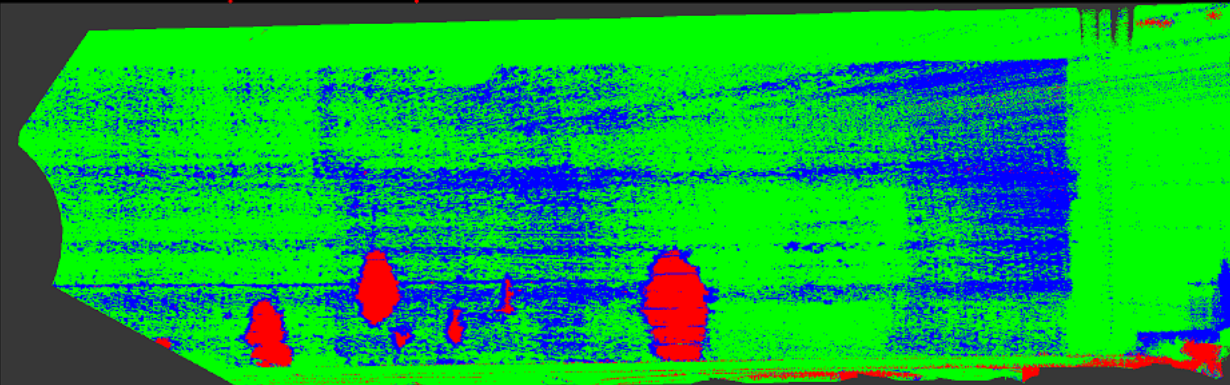
Depth of Hydro demolition (difference from original surface)
Segment 301

Green: Depth of 3/4 inch or less
Blue: Depth of 3/4 inch to Top of Rebar
Red: Deeper than Top of Rebar

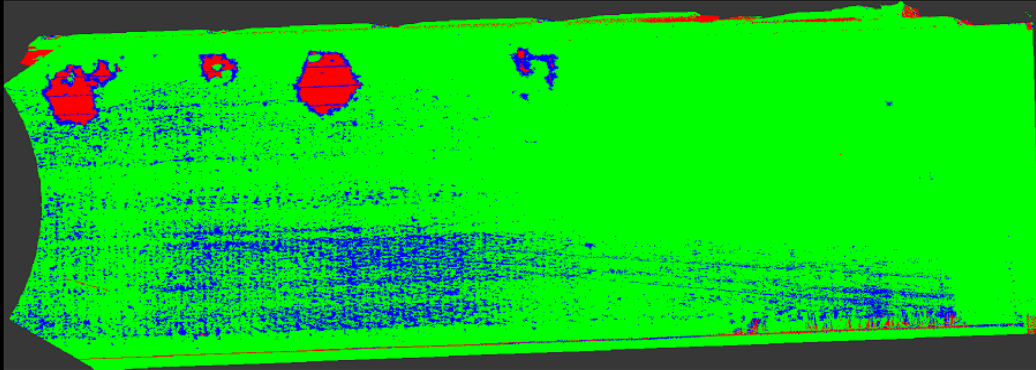
Depth of Hydro demolition (difference from original surface)
Segment 302

Green: Depth of 3/4 inch or less
Blue: Depth of 3/4 inch to Top of Rebar
Red: Deeper than Top of Rebar

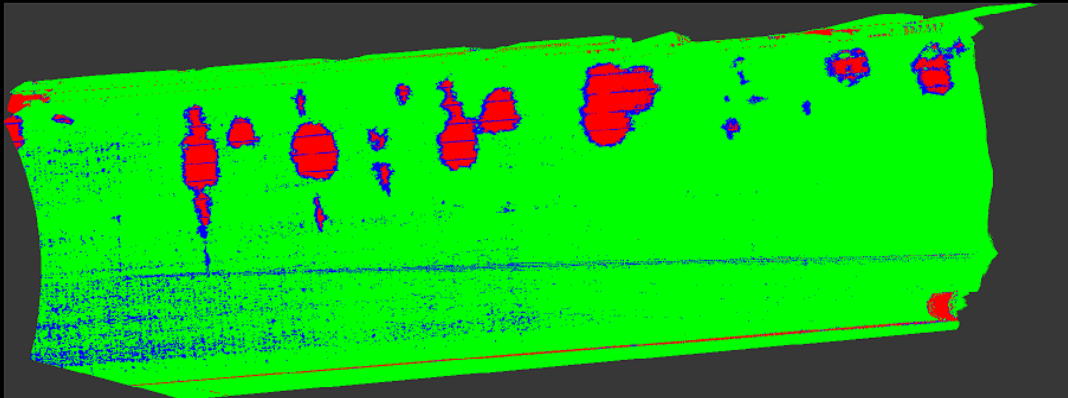
Depth of Hydro demolition (difference from original surface)
Segment 303

Green: Depth of 3/4 inch or less
Blue: Depth of 3/4 inch to Top of Rebar
Red: Deeper than Top of Rebar

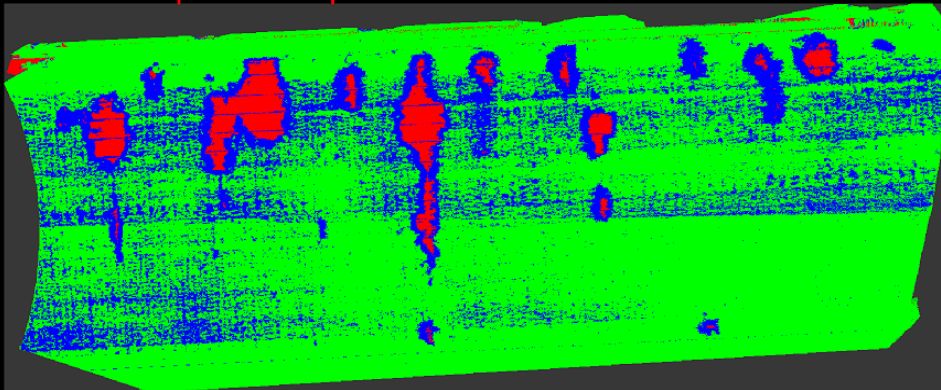
Depth of Hydro demolition (difference from original surface)
Segment 304

Green: Depth of 3/4 inch or less
Blue: Depth of 3/4 inch to Top of Rebar
Red: Deeper than Top of Rebar

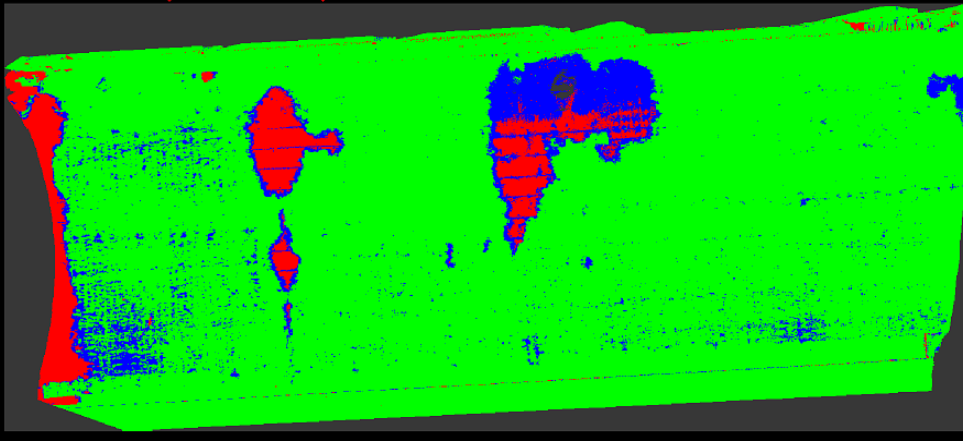
Depth of Hydro demolition (difference from original surface)
Segment 305

Green: Depth of 3/4 inch or less
Blue: Depth of 3/4 inch to Top of Rebar
Red: Deeper than Top of Rebar

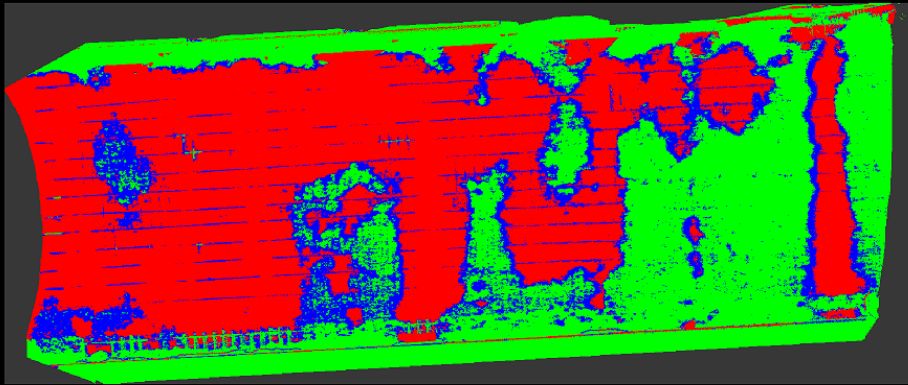
Depth of Hydro demolition (difference from original surface)
Segment 306

Green: Depth of 3/4 inch or less
Blue: Depth of 3/4 inch to Top of Rebar
Red: Deeper than Top of Rebar

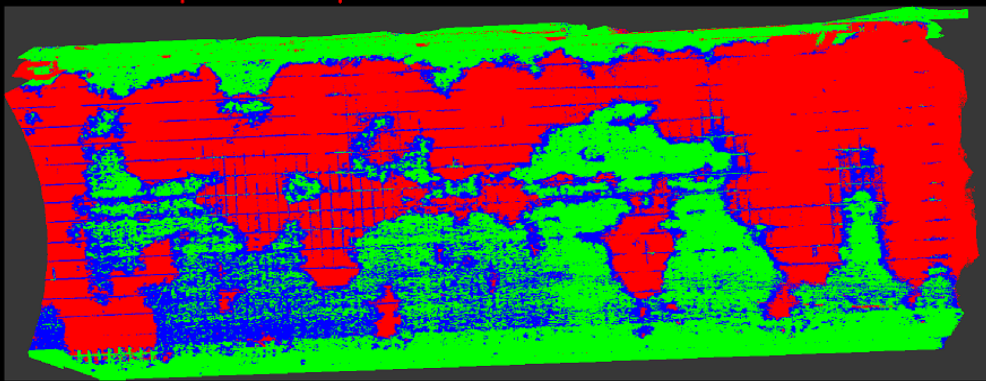
Depth of Hydro demolition (difference from original surface)
Segment 307

Green: Depth of 3/4 inch or less
Blue: Depth of 3/4 inch to Top of Rebar
Red: Deeper than Top of Rebar

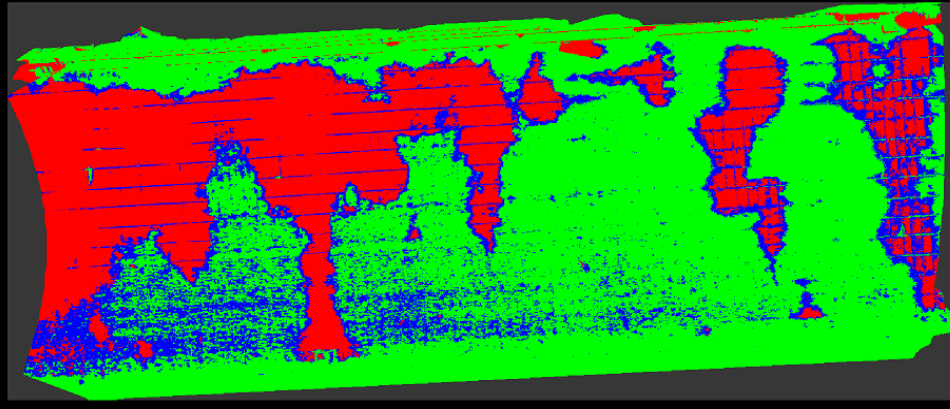
Depth of Hydro demolition (difference from original surface)
Segment 308

Green: Depth of 3/4 inch or less
Blue: Depth of 3/4 inch to Top of Rebar
Red: Deeper than Top of Rebar

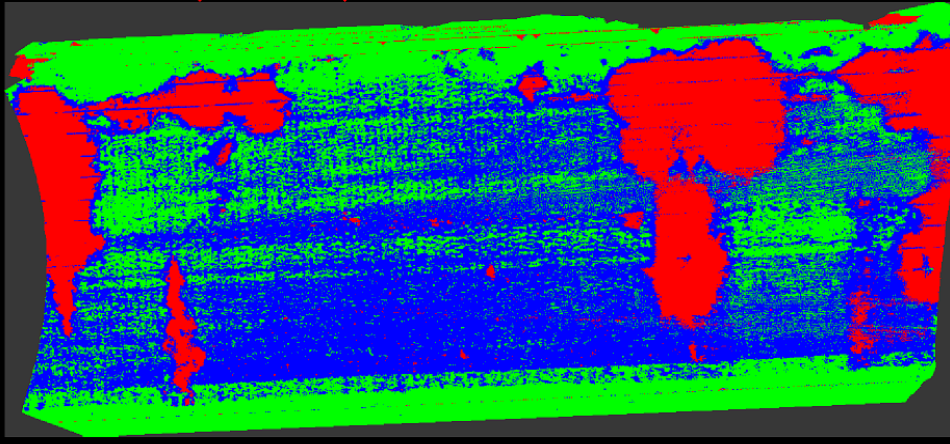
Depth of Hydro demolition (difference from original surface)
Segment 309

Green: Depth of 3/4 inch or less
Blue: Depth of 3/4 inch to Top of Rebar
Red: Deeper than Top of Rebar

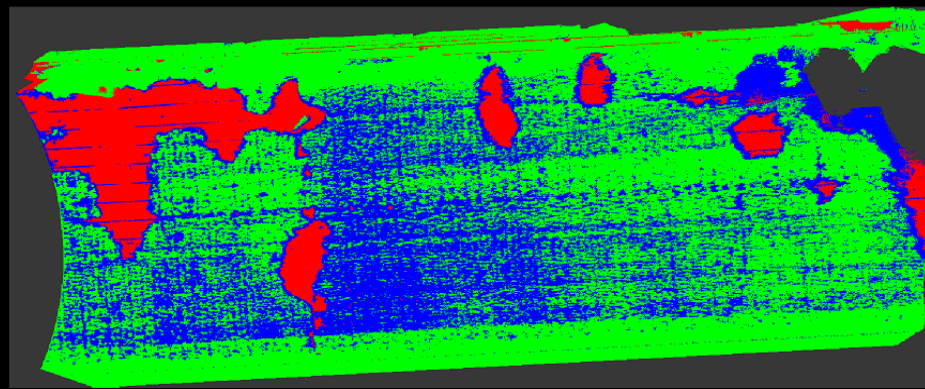
Depth of Hydro demolition (difference from original surface)
Segment 310

Green: Depth of 3/4 inch or less
Blue: Depth of 3/4 inch to Top of Rebar
Red: Deeper than Top of Rebar

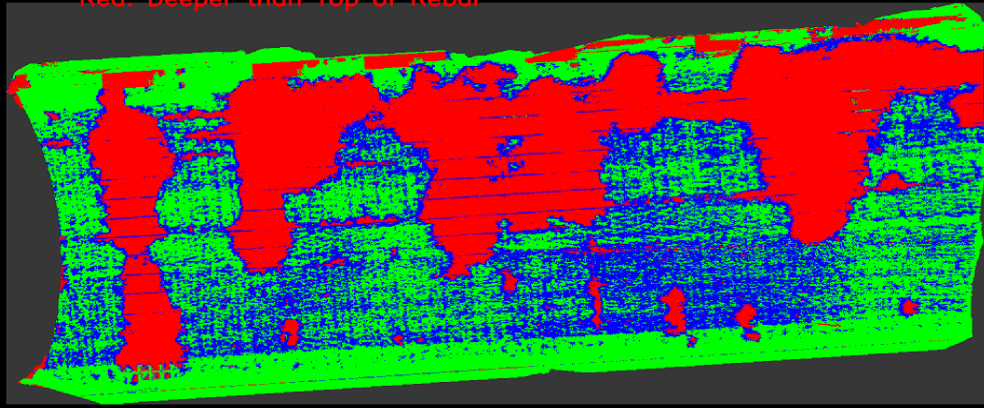
Depth of Hydro demolition (difference from original surface)
Segment 311

Green: Depth of 3/4 inch or less
Blue: Depth of 3/4 inch to Top of Rebar
Red: Deeper than Top of Rebar

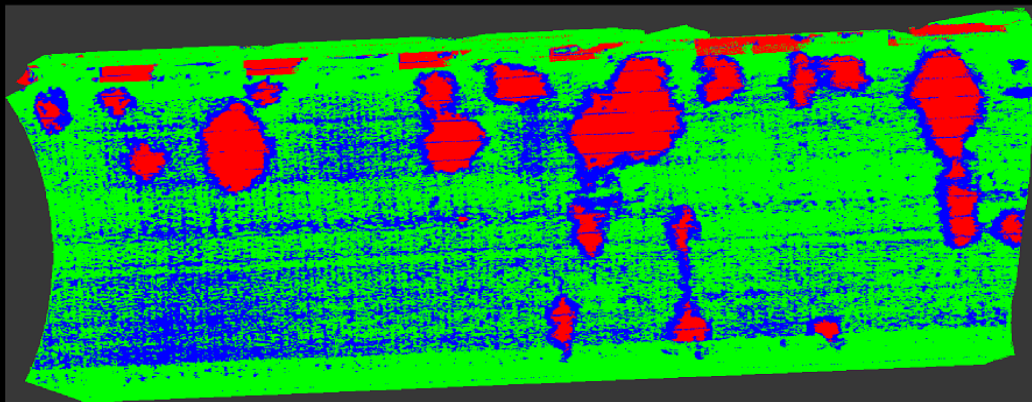
Depth of Hydro demolition (difference from original surface)
Segment 312

Green: Depth of 3/4 inch or less
Blue: Depth of 3/4 inch to Top of Rebar
Red: Deeper than Top of Rebar

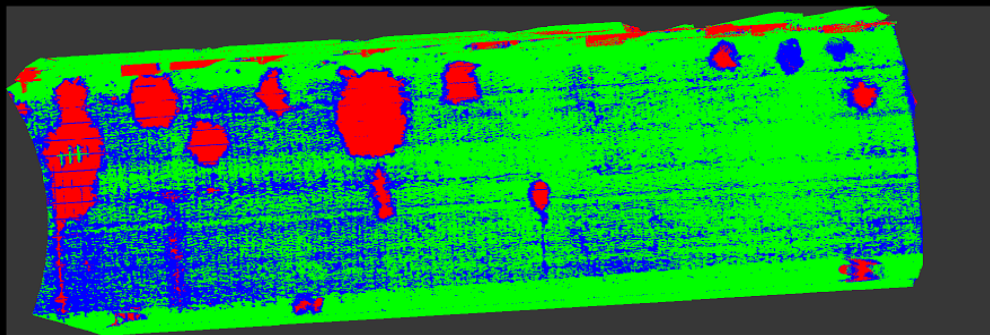
Depth of Hydro demolition (difference from original surface)
Segment 313

Green: Depth of 3/4 inch or less
Blue: Depth of 3/4 inch to Top of Rebar
Red: Deeper than Top of Rebar

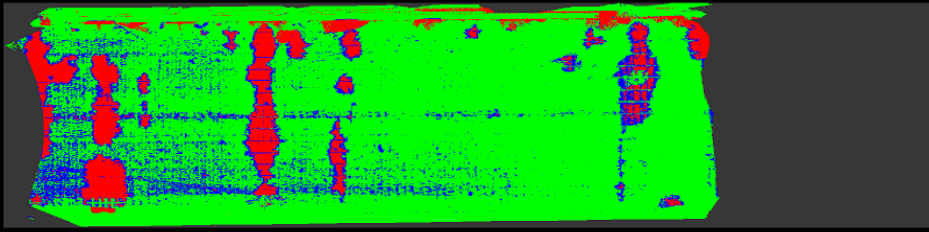
Depth of Hydro demolition (difference from original surface)
Segment 314

Green: Depth of 3/4 inch or less
Blue: Depth of 3/4 inch to Top of Rebar
Red: Deeper than Top of Rebar

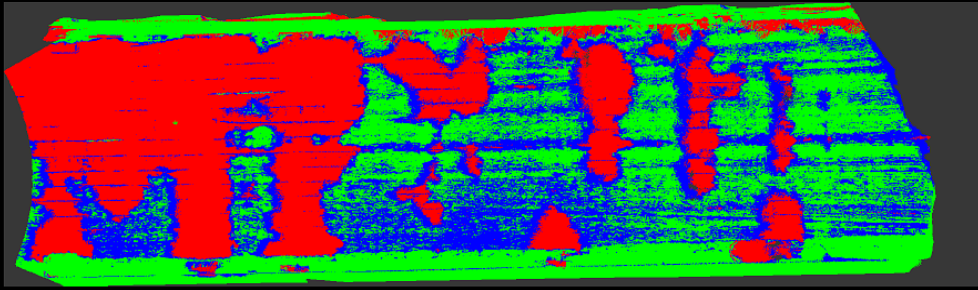
Depth of Hydro demolition (difference from original surface)
Segment 315

Green: Depth of 3/4 inch or less
Blue: Depth of 3/4 inch to Top of Rebar
Red: Deeper than Top of Rebar

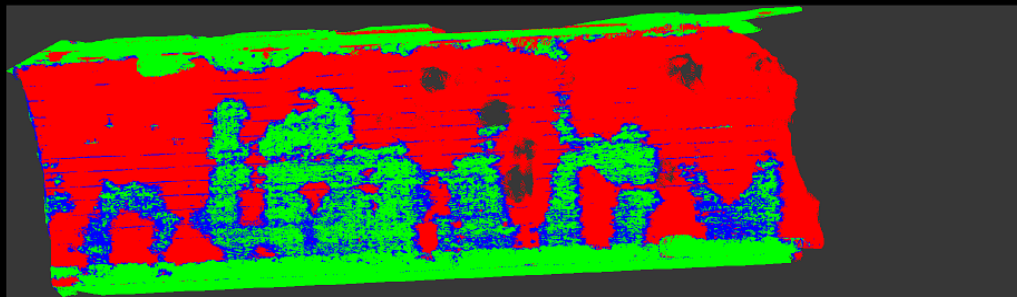
Depth of Hydro demolition (difference from original surface)
Segment 316

Green: Depth of 3/4 inch or less
Blue: Depth of 3/4 inch to Top of Rebar
Red: Deeper than Top of Rebar

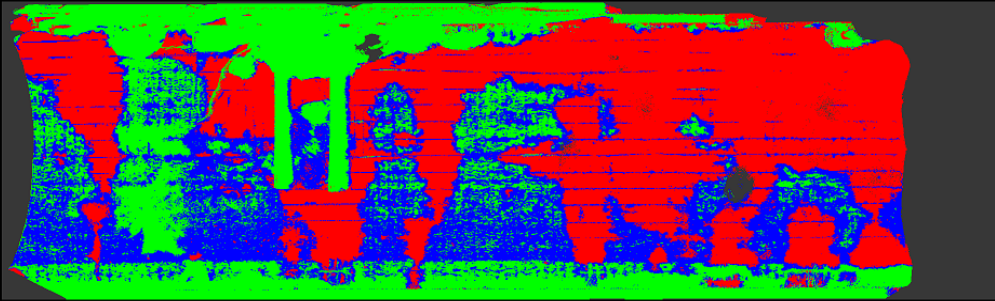
Depth of Hydro demolition (difference from original surface)
Segment 317

Green: Depth of 3/4 inch or less
Blue: Depth of 3/4 inch to Top of Rebar
Red: Deeper than Top of Rebar

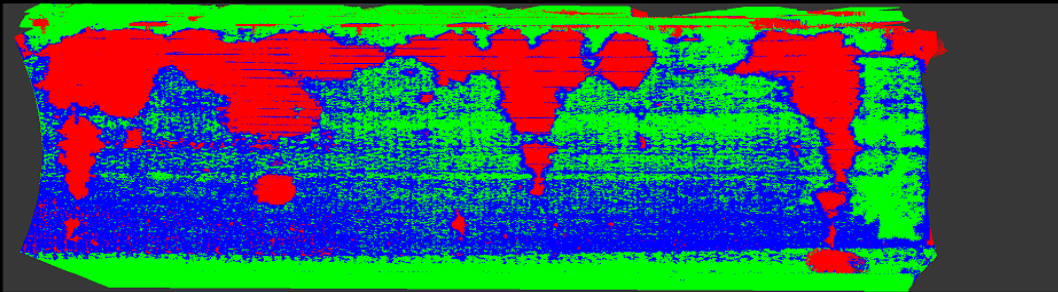
Depth of Hydro demolition (difference from original surface)
Segment 318

Green: Depth of 3/4 inch or less
Blue: Depth of 3/4 inch to Top of Rebar
Red: Deeper than Top of Rebar

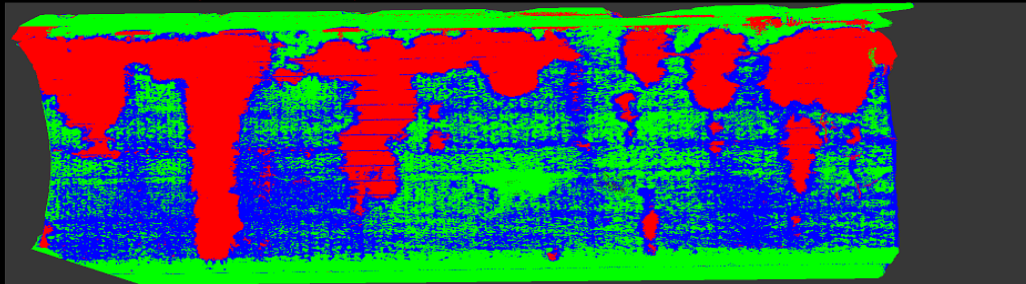
Depth of Hydro demolition (difference from original surface)
Segment 319

Green: Depth of 3/4 inch or less
Blue: Depth of 3/4 inch to Top of Rebar
Red: Deeper than Top of Rebar

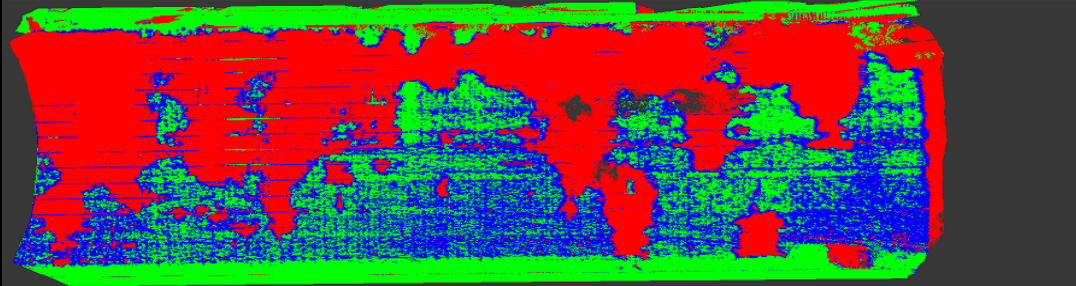
Depth of Hydro demolition (difference from original surface)
Segment 320

Green: Depth of 3/4 inch or less
Blue: Depth of 3/4 inch to Top of Rebar
Red: Deeper than Top of Rebar
