**Preservation of Missouri  
Transportation Infrastructures:  
Life-Cycle Inspection and Monitoring  
of FRP-Strengthened Concrete Structures  
using Near-Field Microwave Nondestructive  
Testing Methods**

S. Kharkovsky, V. Stephen,  
A.C. Ryley, J.T. Robbins and R. Zoughi

**UTC  
R97**

**PRESERVATION OF MISSOURI  
TRANSPORTATION INFRASTRUCTURES**  
VALIDATION OF FRP COMPOSITE TECHNOLOGY  
THROUGH FIELD TESTING

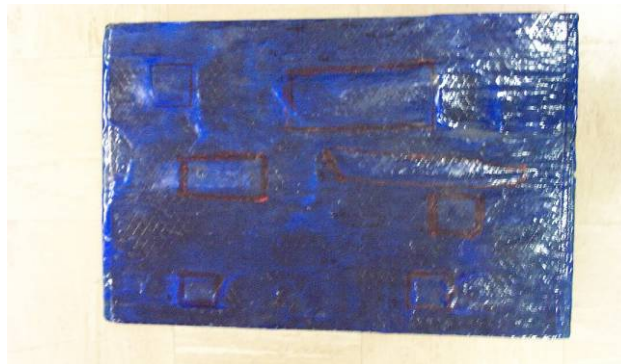
CFRP laminates were adhered to several cement-based samples after curing using the manual lay-up method. During the lay-up process, several intentionally disbonded regions were produced in each sample. Two of these samples are shown in Figure 11. Sample #1 (Figure 11a) was a 380 mm by 520 mm by 90 mm mortar slab adhered with a CFRP laminate. A 60 mm by 80 mm rectangular disbonded region was produced by inserting a thin sheet of foam between the CFRP laminate and the mortar substrate. Sample #2 (Figure 11b) was a 380 mm by 520 mm by 78 mm mortar slab with several disbonded regions produced in it by injecting air between the CFRP laminate and the mortar substrate (i.e., creating a thin airgap between CFRP and mortar). The manufactured disbonds varied in size, geometry and thickness, and ranged in area from approximately a few to several squared centimeters [4]. Some of the disbonds also bulged up a bit creating local surface roughness that when scanned would result in standoff distance variation around it.

Figure 11 - Picture of two CFRP cement-based samples.
